# Technical report

## IN-001/2024

Incident occurred on 17 February 2024 to aircraft Airbus A321, registration D-AISO, in Madrid (Spain)

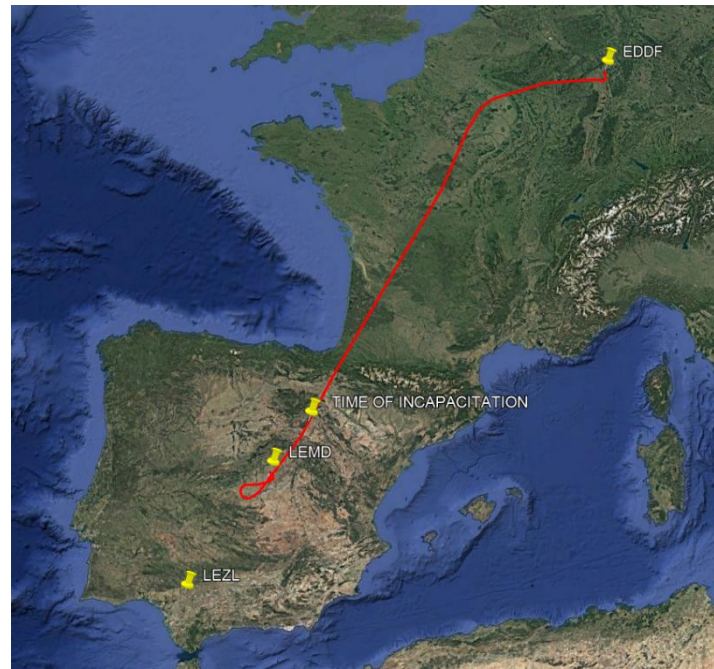
Figure 1: Flight path

The map on the right shows the aircraft's flight path from the time it took off from Frankfurt Airport until it landed at Adolfo Suarez Madrid-Barajas Airport.

It also shows how the aircraft diverted to the latter airport while flying towards its intended destination, Seville Airport:

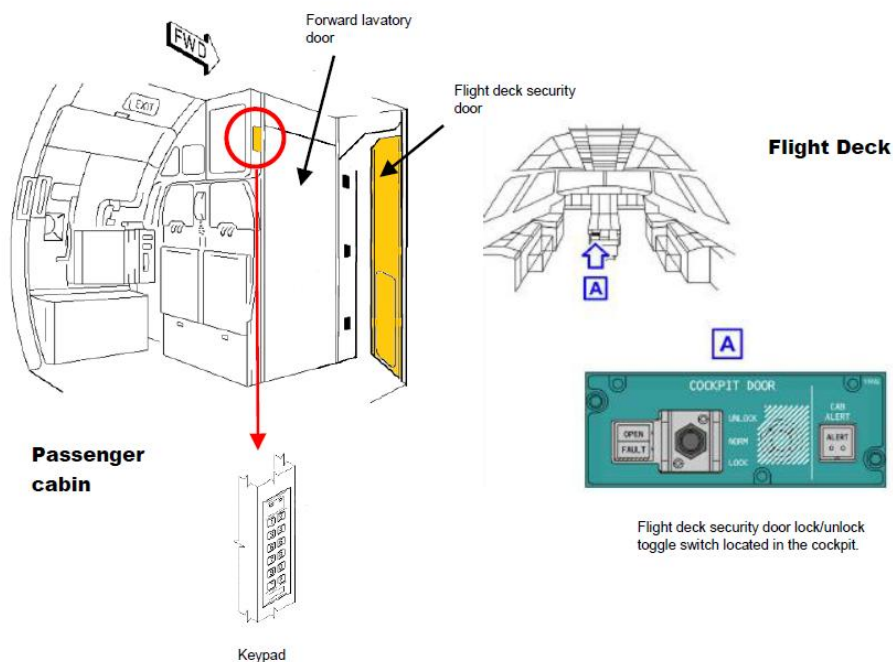
Figure 2: *Flight deck security door*

In order to access the flight deck from the passenger cabin, part of the entry procedure involves entering a standard access code on a numeric keypad near the door. Entering this code generates an audible chime to alert pilots of the request to enter the flight deck. The pilots can authorise entry from inside the flight deck by unlocking the door from a toggle switch on the pedestal.

In an emergency (e.g. if pilots do not respond to requests for entry) the door can be unlocked by entering an emergency code on the same keypad. Entering the emergency code generates a more noticeable sound to warn the pilots of this situation. When this happens, the door unlocks automatically after a specified delay. The flight crew has the possibility to prevent the automatic unlocking of the cockpit door by setting the toggle switch to “LOCK”.

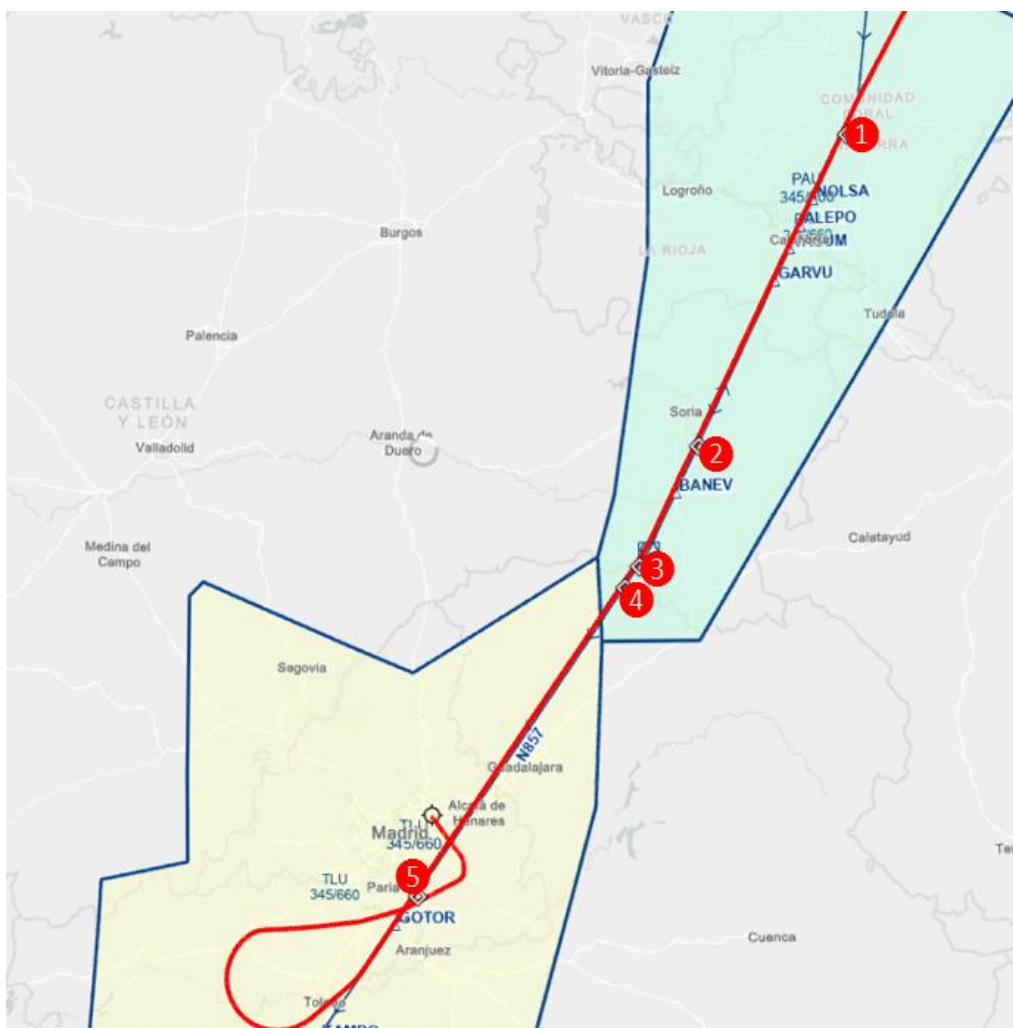
Figure 3: Flight path of the aircraft in the PAU (green) and TLU (yellow) sectors

Subsequently, at 10:34:51 UTC (see ③ in Figure 3), when the co-pilot was alone on the flight deck, the controller made three attempts to contact the crew to transfer control of the aircraft to the next en-route sector, the TLU. There was no response from the co-pilot as he was incapacitated.

At 10:35:31 UTC (see ④ in Figure 3), the controller of the PAU sector contacted the TLU sector, at the same time as another Lufthansa aircraft contacted the TLU sector. Upon hearing the callsign, the controller of the PAU sector assumed that it was the one involved in the incident (the controller of the TLU sector initially mistakenly addressed the other Lufthansa aircraft with the call sign LH77X).

The next communication with ATC occurred after the captain returned to the flight deck. He contacted the PAU sector controller at 10:43:51 UTC (see 5 in Figure 3) to ask to descend, explaining that they had a medical problem on board, and requested vectors to LEMD. The aircraft was transferred to the TLU sector frequency. Subsequently, it declared a medical emergency and requested the service of an ambulance. The air traffic controllers coordinated with the airport manager to facilitate medical assistance, assigning the aircraft to a parking stand near the runway and arranging for an ambulance to meet it on arrival.

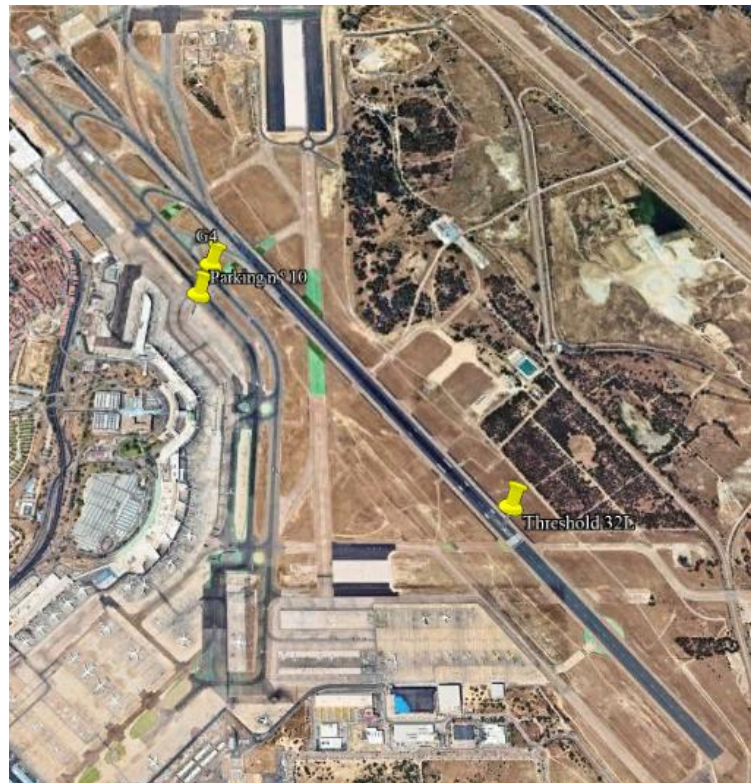
Figure 4: Image of LEMD airport

The aircraft involved in this event landed on runway 32L and was assisted by a “follow-me” vehicle to parking stand nº. 10, where an ambulance was waiting to attend to the co-pilot.

The runway 32L threshold, zone G4 and parking stand nº. 10 assigned to the aircraft are marked on the plan on the right.

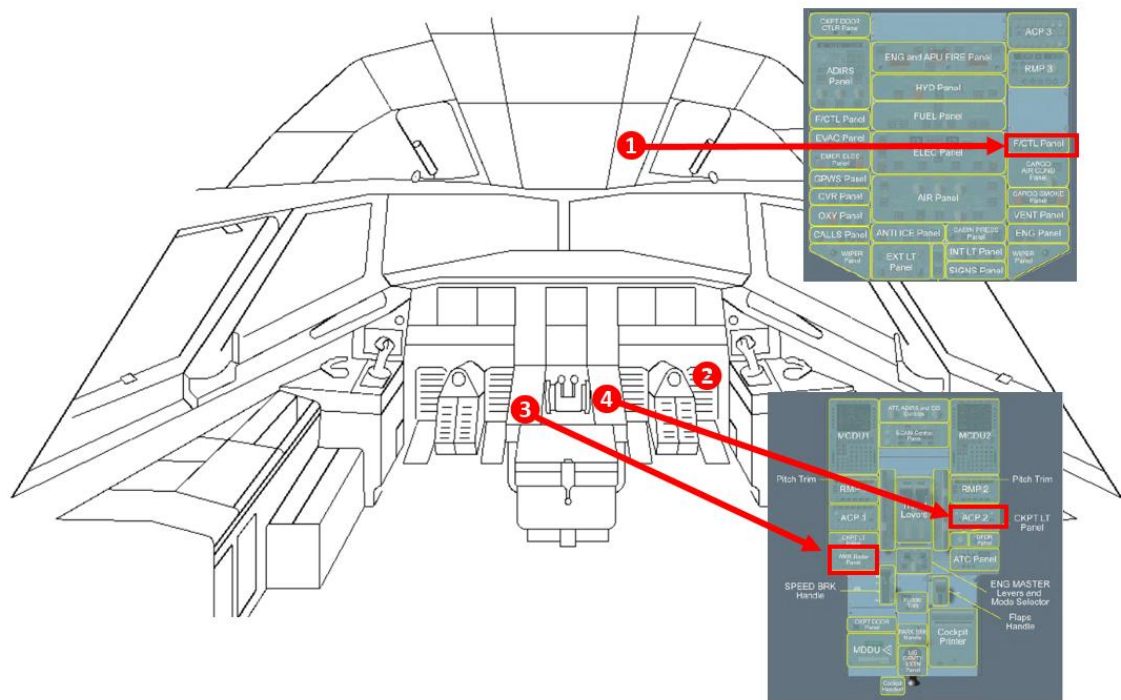
Figure 5: Co-pilot's involuntary actions while incapacitated

The image of the flight deck below shows the position of the controls and switches that the co-pilot inadvertently operated during the first 46 seconds of the incapacitation:

Time in UTC	Event
①	10:32:15	SEC 3 P/B SW in OFF
②	10:32:19	Sudden increase in force on the right pedal
③	10:32:29	EFIS_Radar/EGPWS OP MD changes from WS+Turbulence to Turbulence, and remains in that setting until the end of the flight
④	10:32:49	The morse identification of the VOR BAN begins to be audible

The autopilot and autothrust systems remained engaged. The action on the right pedal caused a 5° roll and a 2° heading change, which were compensated for by the autopilot<sup>9</sup>. The aircraft continued to fly the planned route and, after the BANEV waypoint, continued towards the BAN VOR, turning towards the GOTOR waypoint at 10:34:11 UTC, following the airway.

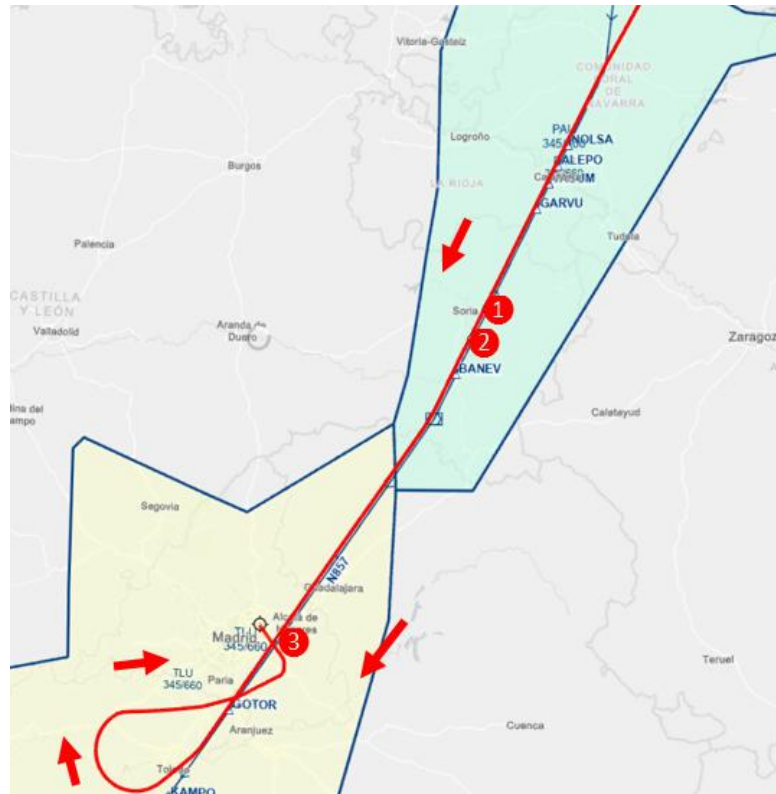
Figure 6: Flight path of the aircraft on the ENAIRE route map

Time in UTC	Event
①	10:31:30	The captain leaves the flight deck
②	10:32:06	Incapacitation of the co-pilot begins
③	10:42:04	The captain enters the flight deck
