THE SPACE SHUTTLE *COLUMBIA* ACCIDENT INVESTIGATION: TOOLS, TECHNIQUES, AND RESULTS

S. McDanel, NASA, Kennedy Space Center, Florida, USA
M. Solomon, Boeing, Kennedy Space Center, Florida, USA

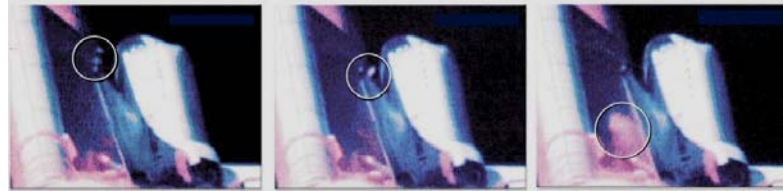
The space shuttle *Columbia* launched (Figure 1) from the Kennedy Space Center in Florida on January 16, 2003, at 10:39 a.m. EST. Approximately 81 seconds into the ascent, a piece of debris, likely foam from the external tank, struck the left wing of the *Columbia* (Figure 2), although the exact location of the impact, and resultant damage, could not be immediately determined. It was later estimated that the debris struck at an impact velocity of mach 2.46.

FIG 2. Debris Strike on Left Wing

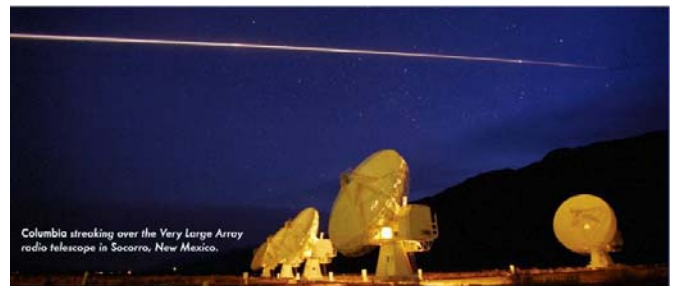
Sixteen days later, on February 1, 2003, the *Columbia* had completed the space-based portion of its mission and was beginning its descent back to Earth. One minute and twenty-four seconds into the peak heating portion of the re-entry, a left main landing gear brake line indicated a temperature rise in that region; shortly thereafter, numerous additional sensors in that area likewise indicated an increase in the localized temperature. Nearly seven minutes later, at approximately 8:59 a. m. EST, loss of signal occurred between the *Columbia* and Mission Control; within forty-five seconds the orbiter began to disintegrate (Figure 3).

FIG 3. *Columbia* disintegrating

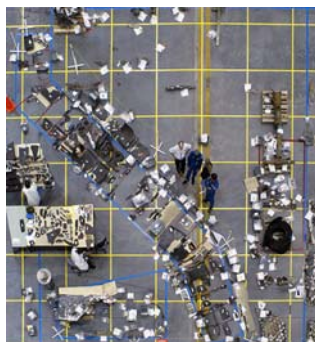
FIG 4. Remnants of Panels 1-22 of the Left Wing Leading Edge

As is typical in any investigation, whether a routine failure analysis or the most wide scale mishap investigation in aerospace history, sampling, testing and analysis was conducted sequentially from the least invasive to the most destructive. After only a few samples were harvested from the various remnants, it was soon evident that more surface-sensitive techniques such as XPS and ESCA would only divulge what had been deposited last in the sequence of events immediately preceding the loss of the orbiter, and not help determine the underlying compositions. Likewise, XRD could help show what, if any, compounds were present, but could not furnish the ratios of compounds or their layering and sequencing characteristics. The samples which were subjected to the above methods tended to be loosely adherent "slag" deposits. Although the term "slag" is a metallurgical misnomer in this case, that is the terminology that was used throughout the investigation. It was evident that the interior portions of the left wing leading edge were more heavily covered with slag deposits near panels 8 and 9. The further away from that region- the less slag was found.

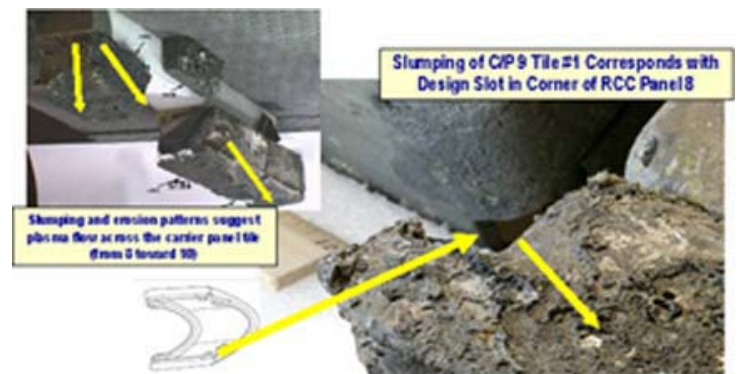
FIG 5. Thermal Degradation Evidence of Hot Gas Flow Exiting Design Slot Indicates Significant Breach Was Into Panel 8

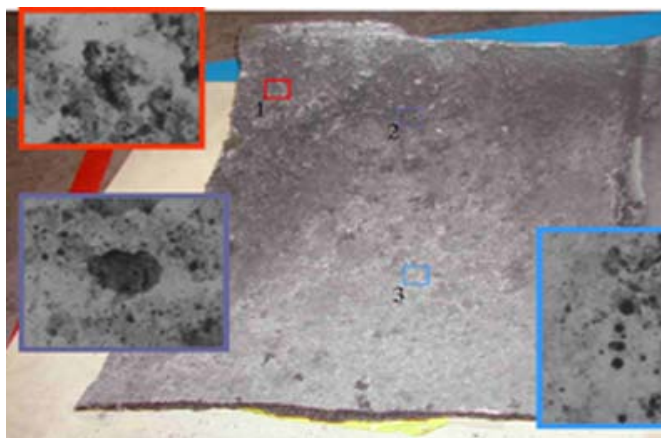
FIG 6. Inverse Radiograph Of The Left-Hand Reinforced Carbon- Carbon Panel Number 8 Upper Apex Displaying Three Distinct Deposition Types and Locations

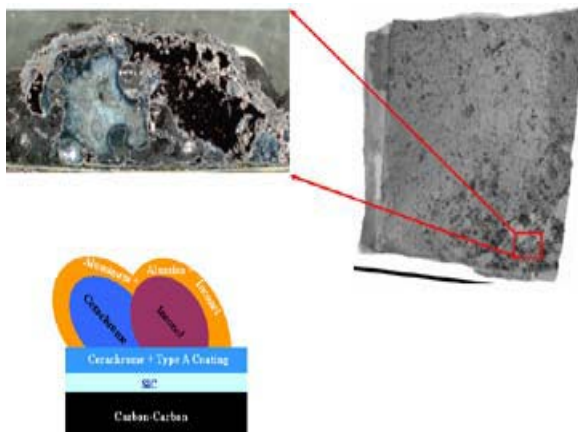
FIG 7. Inverse Radiograph, Metallographic Cross Section, and Schematic Analytical Representation of Panel 8 Piece

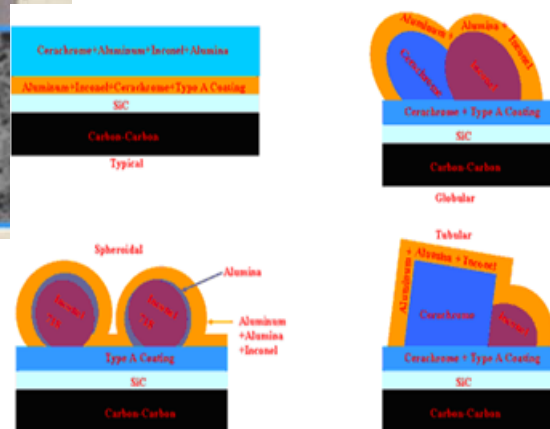
Four types of deposits were found on the interior of the wing: globular, spheroidal, tubular, and typical (Figure 8). The globular deposits were found mainly on the apex of the interior of the RCC panels and contained re-solidified cerachrome insulating material, which has a melting point of approximately 1,649° C. The spheroidal deposits had a large concentration of Inconel 718, and were found mainly in the interior upper central portion of the panels. The tubular deposits, with their corresponding composition of cerachrome, were found on the upper region of the interior of the panels, opposite the plasma entry point (Figure 9).

FIG 8. Schematic Representation of Deposit Type and Composition Of Samples From Figure 6. Dr. Greg Jerman, NASA-MSFC

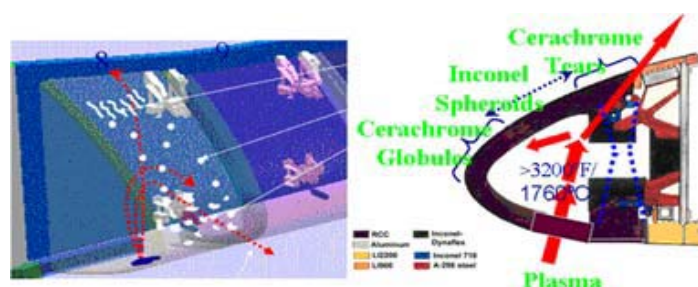
FIG 9. Proposed Breach Location and Impingement Path

in the chemical analyses indicated that the interior attach fittings were not in the path of the flow, further helping back trace the breach location. When taken together, it became apparent that heat damage was most severe in, and occurred first, near panels 8 and 9 on the leading edge of the left wing, corresponding to the suspected area of the foam strike during ascent.
