Aircraft Cabin Air and Engine Oil – An Engineering Update

Dieter Scholz

Hamburg University of Applied Sciences

International Aircraft Cabin Air Conference 2021

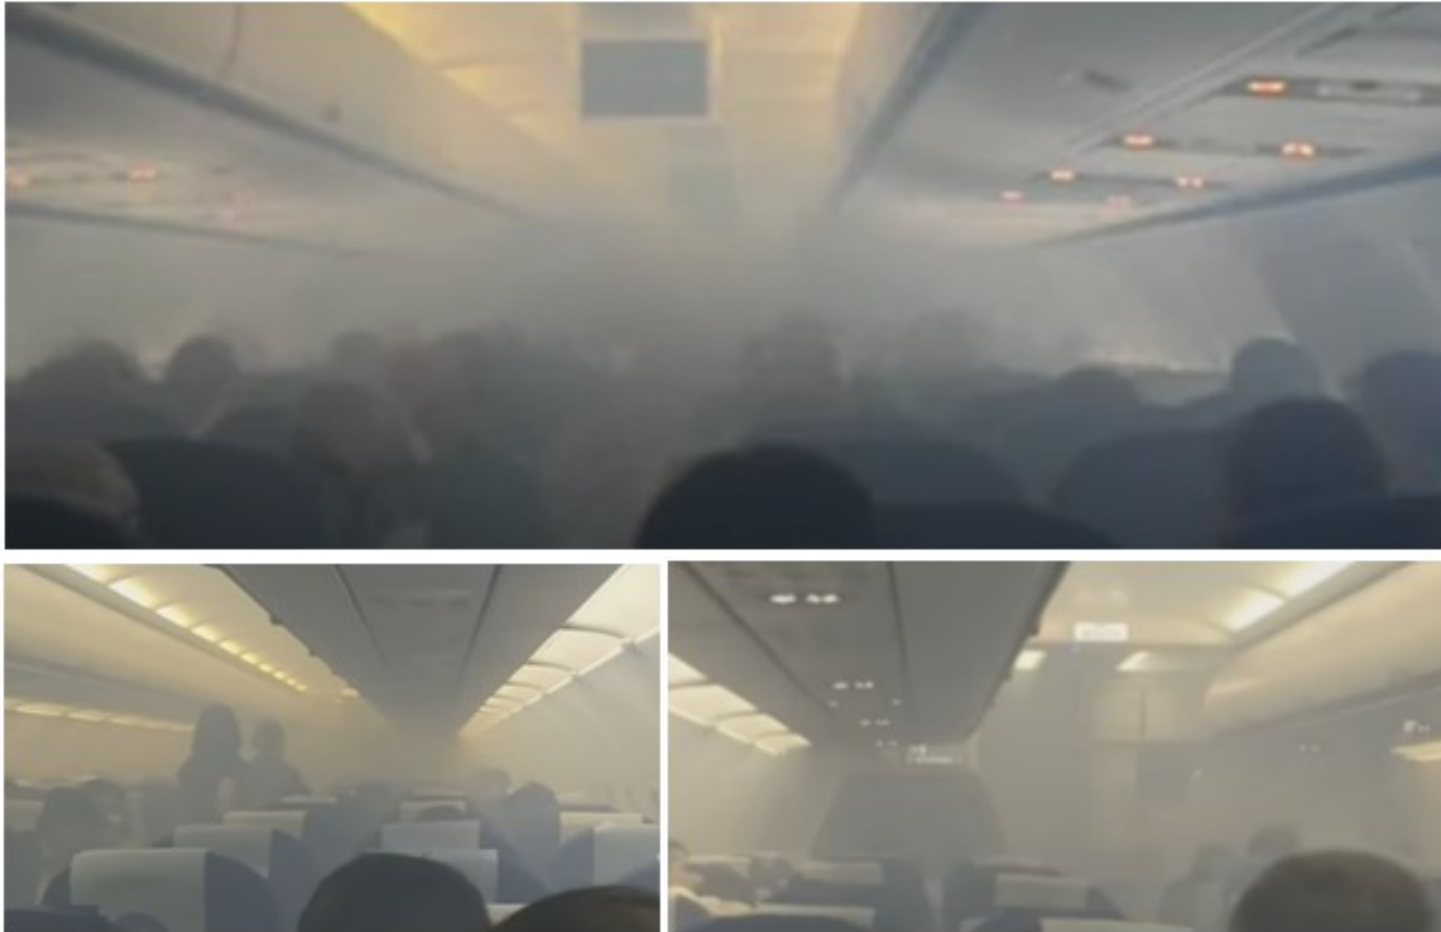
Cabin Air Contamination Event Due to Engine Oil After Technical Fault

Top: 2010-09-17, US Airways US-432, Boeing 757-200. Bottom: 2018-12-10, Indigo flight 6E-237, Airbus A320neo.

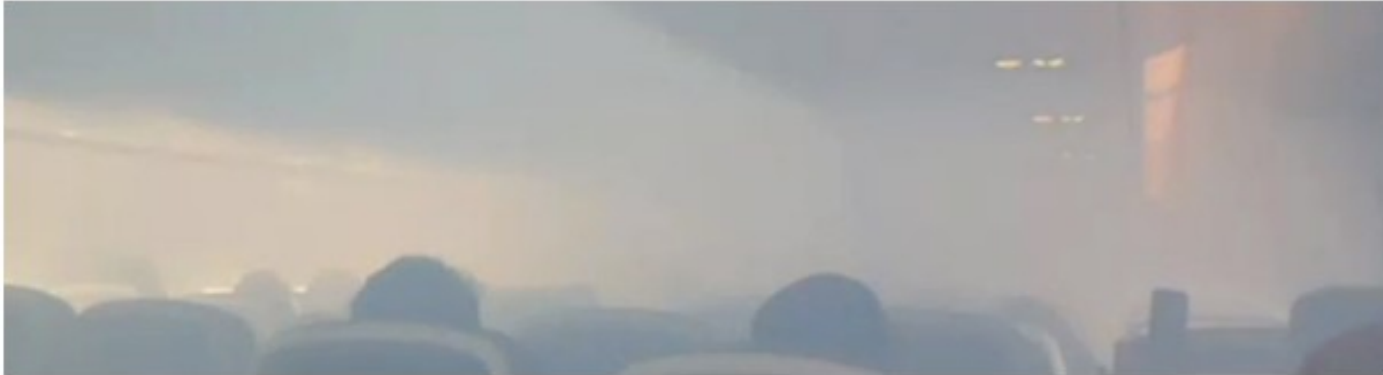
Cabin Air Contamination Event Due to Engine Oil After Technical Fault

Top: 2019-08-22, Hawaiian Airlines HA47, A321neo. Bottom: 2019-08-05, British Airways BA-422, Airbus A321.

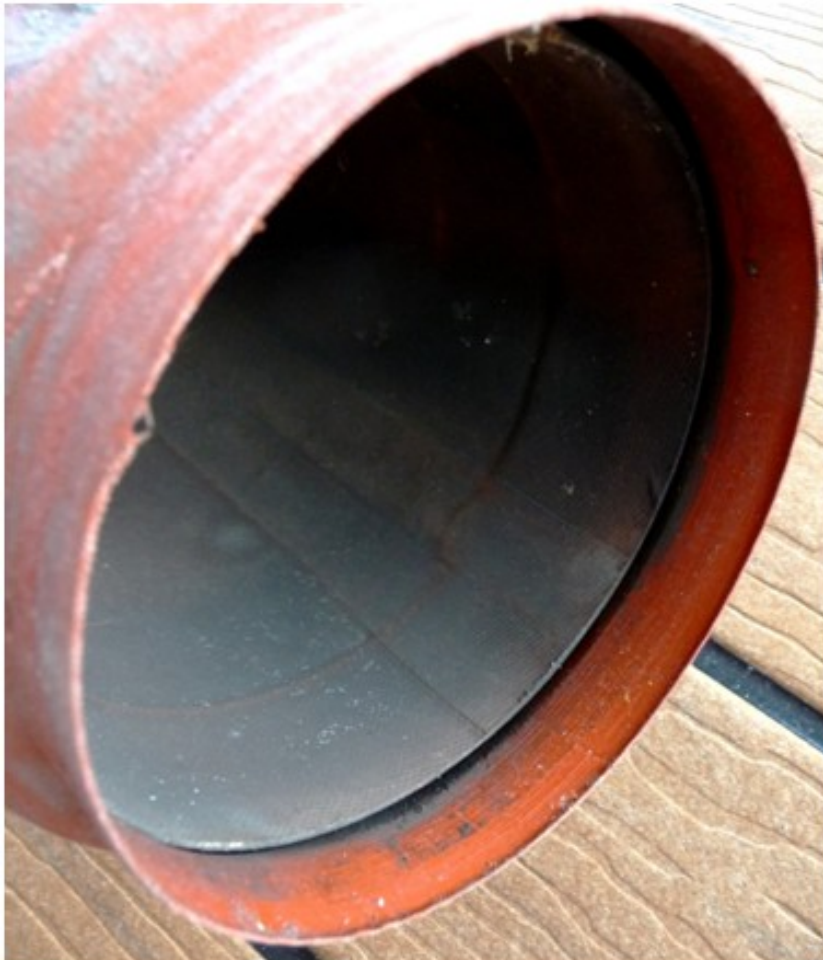
Engine Oil Colors Cabin Air Duct Black

Airbus A320 air conditioning air distribution duct in the cabin. The inside is black from contaminated bleed air.

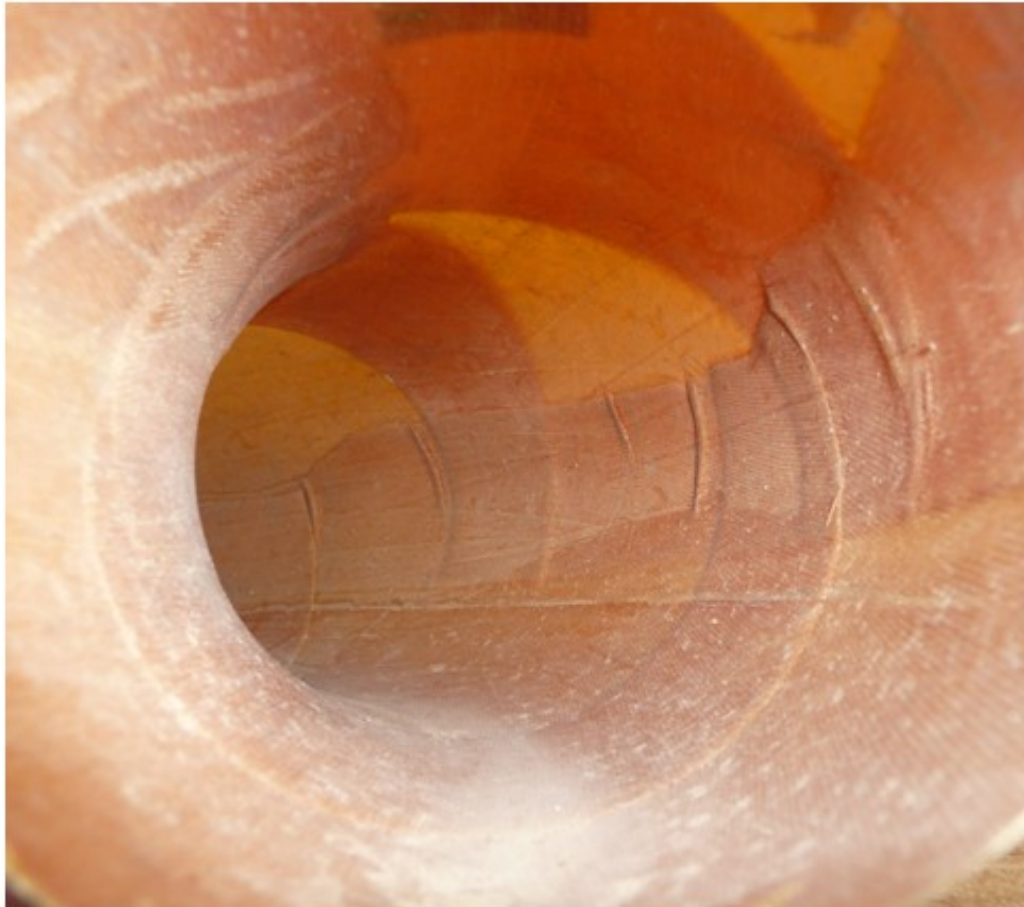
Air Duct Is Clean at End of Life of an Aircraft, if Not Fed With Bleed Air

The inside of the air extract duct (located near the extract fan) is **clean** at the end of life of an Airbus A320, **because** the duct is normally **not fed with bleed air**.

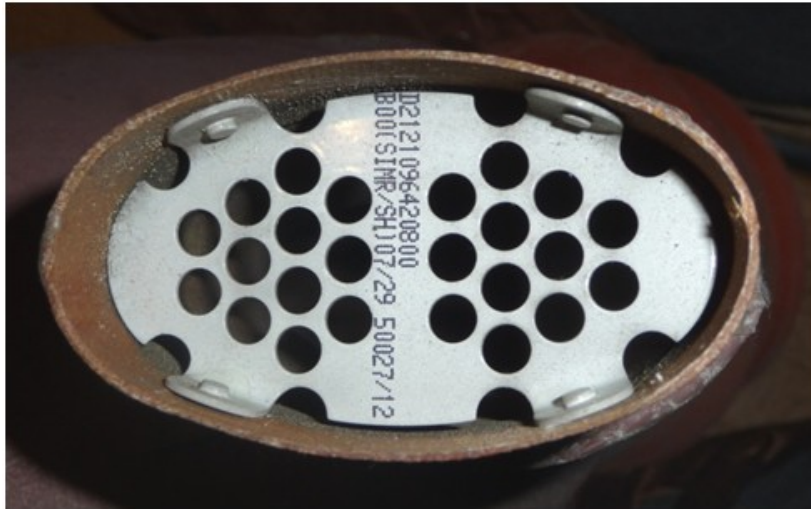
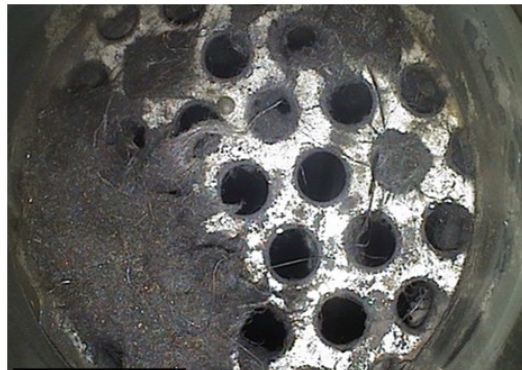
Flow Limiter in Air Conditioning Ducts Clogged

Flow limiter clogged from pyrolysed engine oil in ducts of the air conditioning system of Boeing 757 aircraft with Rolls-Royce RB211-535E4 engines operated by Icelandair (Hansen 2019) compared to a clean flow limiter (top).

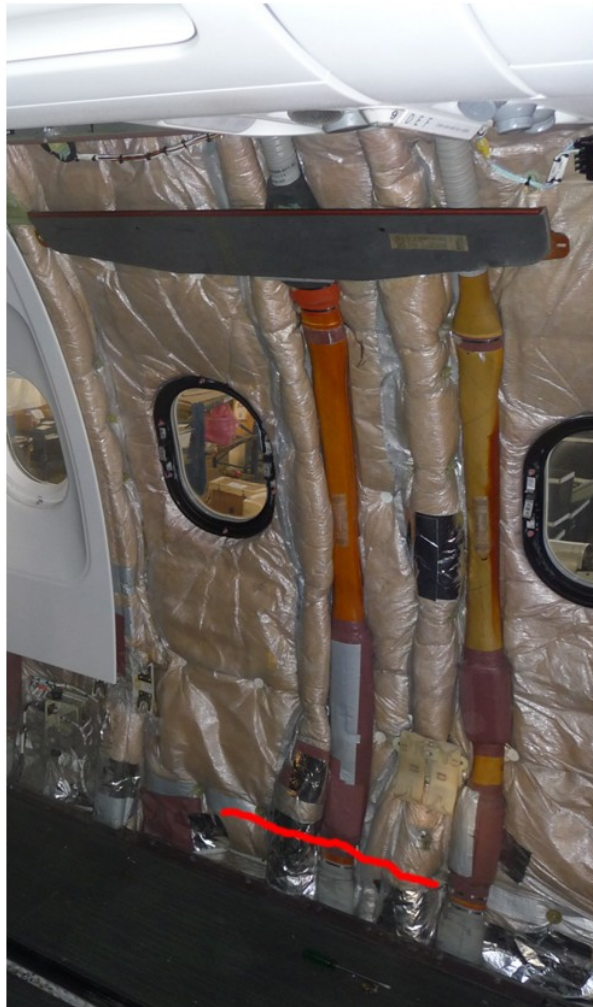
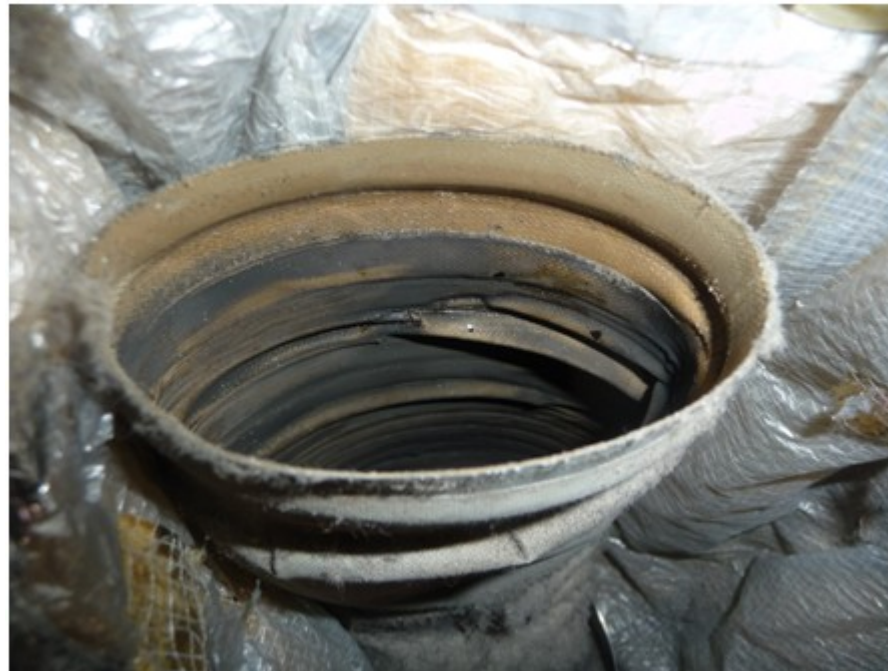
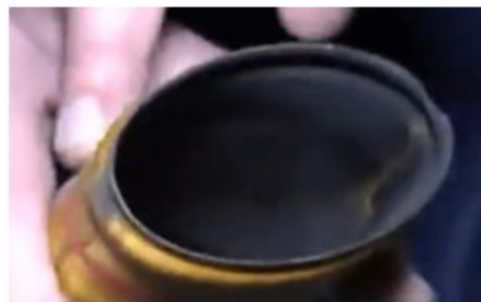
Engine Oil Colors Riser Ducts Black

Riser ducts and lower cabin air outlet on an Airbus A320 aircraft. The red line close to the cabin floor shows, where the **duct was** separated and **opened**. It is **black inside** from **engine oil residue**.

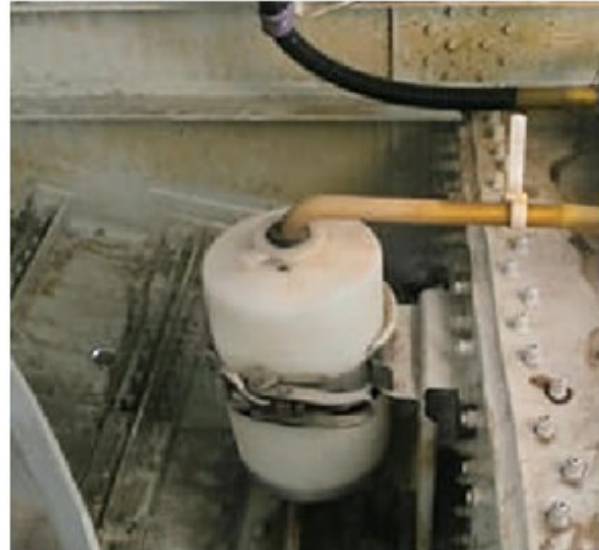
"Zero Leakage" of Hydraulic Systems Has Not Been Achieved

Aft collector tank of the A320 hydraulic seal drain system. In this old Airbus A320, **all surfaces** in the landing gear bay **are covered with a layer of hydraulic fluid**. Dirt accumulates on the sticky surface. **The hydraulic fluid is not confined to the inside of the hydraulic bay, but continues its journey on the lower side of the fuselage towards the APU inlet** (previous page).

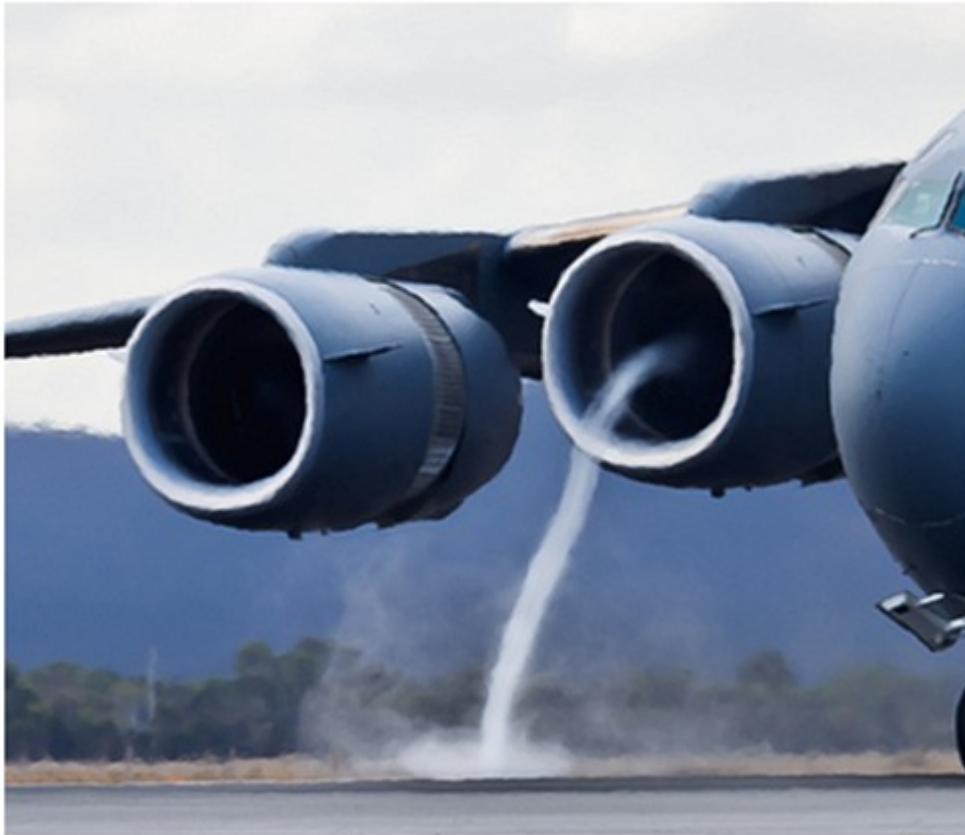
The ground vortex can also form between the ground and an engine on a high wing (Childs 2017).

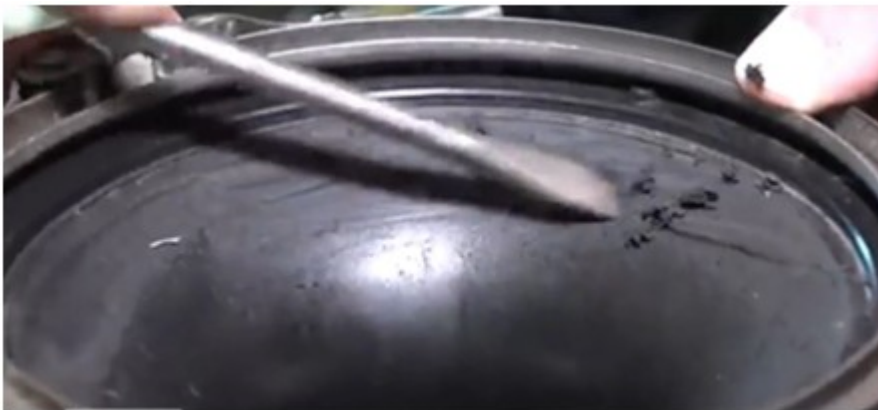
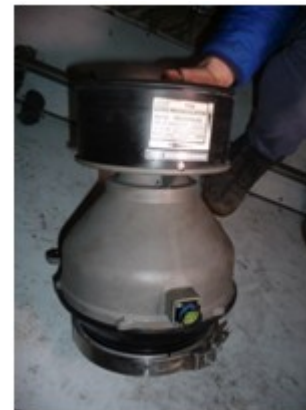
Contaminated Recirculation Fan

The face of the **recirculation fan** of an Airbus A320 is covered by an **oily back soft substance** that can be scraped off with a screw driver. Picture source: **Video**: <https://bit.ly/2YXcL3a>

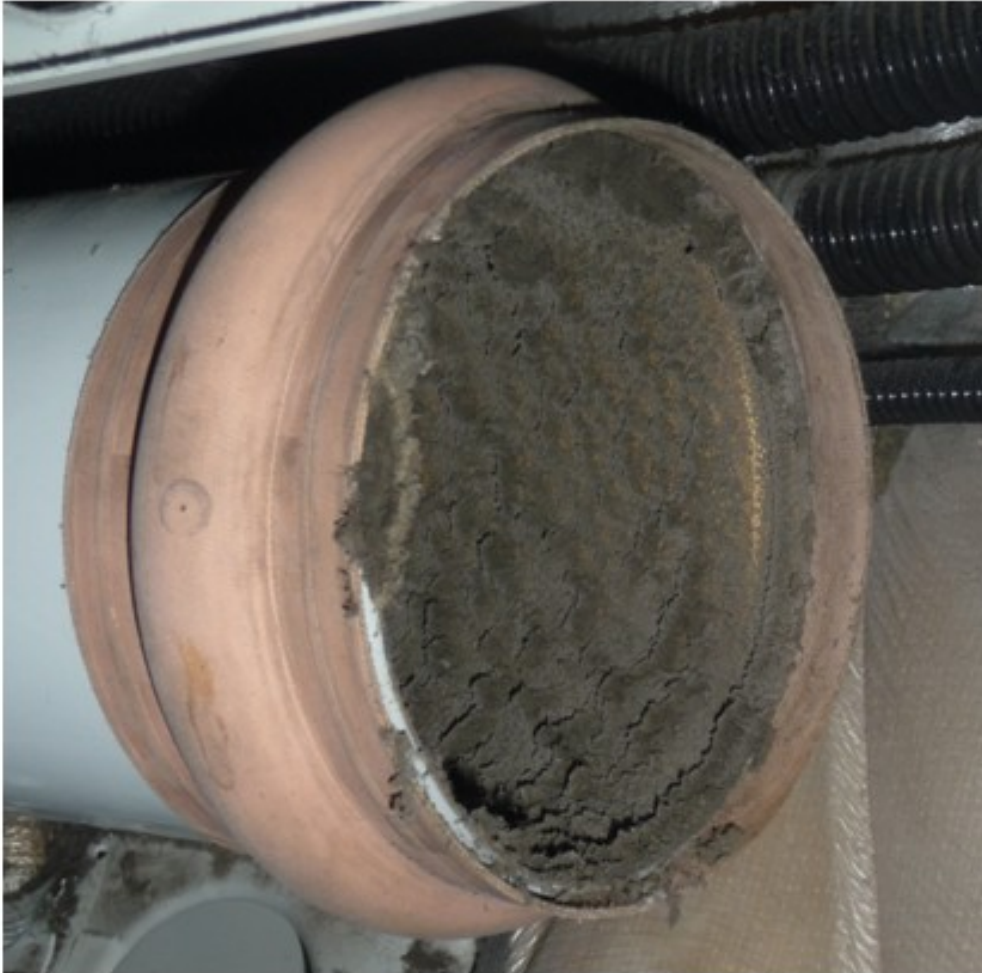
Contaminated Cargo Compartment Heating

The ambient air inlet in the cargo compartment of the Airbus A320 for **cargo compartment heating** and ventilation. The inlet is full of **moist dust**.
