AIRCRAFT CABIN AIR
International Conference 2021

Aircraft Cabin Air and Engine Oil – Routes of Contamination

Scholz, Dieter

Aircraft Design and Systems Group (AERO), Hamburg University of Applied Sciences, Hamburg, Germany

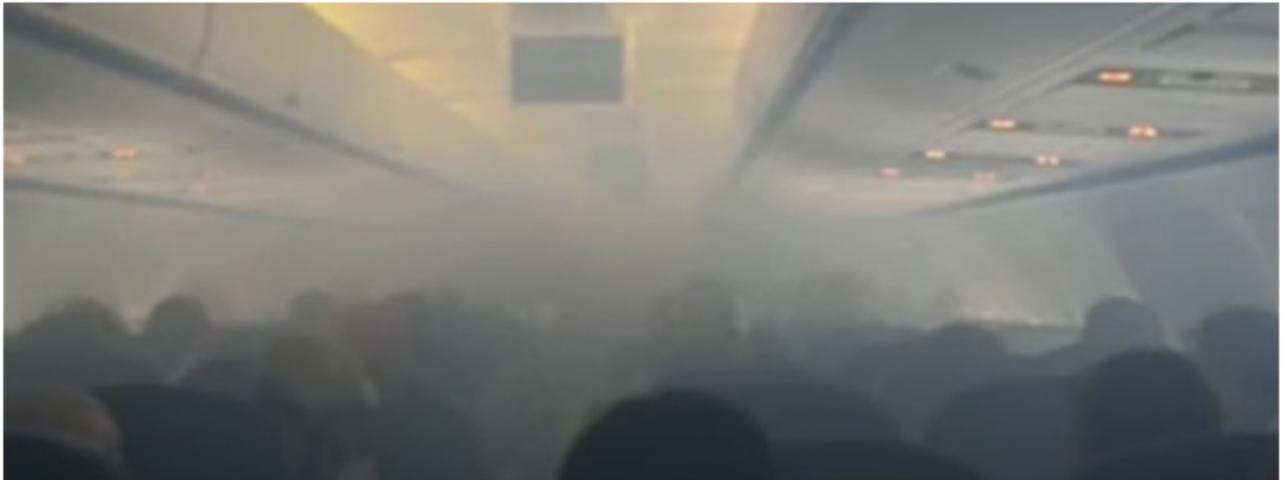
The **Figures 6 to 9** show the inside of a cabin in a Cabin Air Contamination Event (CACE) due to engine oil after a technical fault.

Figure 6 2010-09-17, US Airways US-432, Boeing 757-200. Maui-bound flight enroute overhead the Pacific diverted to San Francisco (1200 nm). More: AvHerald 2010. Picture source: Video: <https://youtu.be/AZqeA32Em2s>.

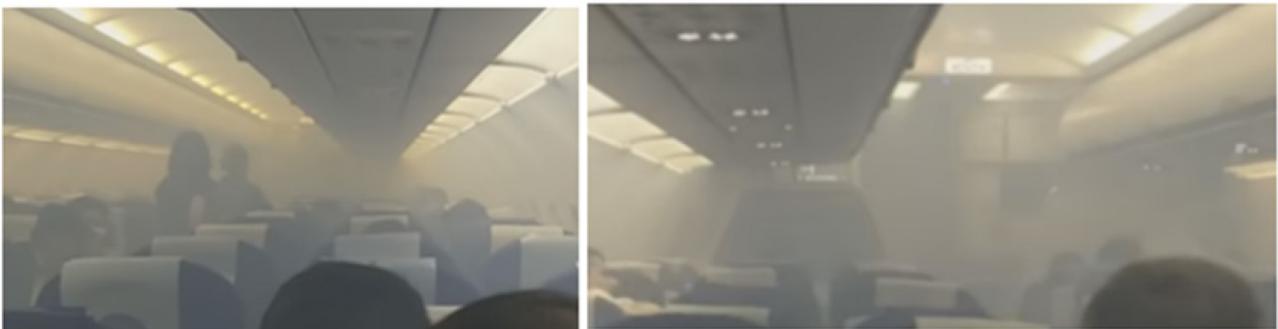
Figure 7 2018-12-10, Indigo flight 6E-237, Airbus A320neo, Jaipur to Kolkata, India. The smoke was traced down to the engines (PW1127). This and more: AvHerald 2018. Cause: Leakage of oil from the engine (Telegraph 2018). Picture source: Video: https://youtu.be/TO_FZ3L4yus.

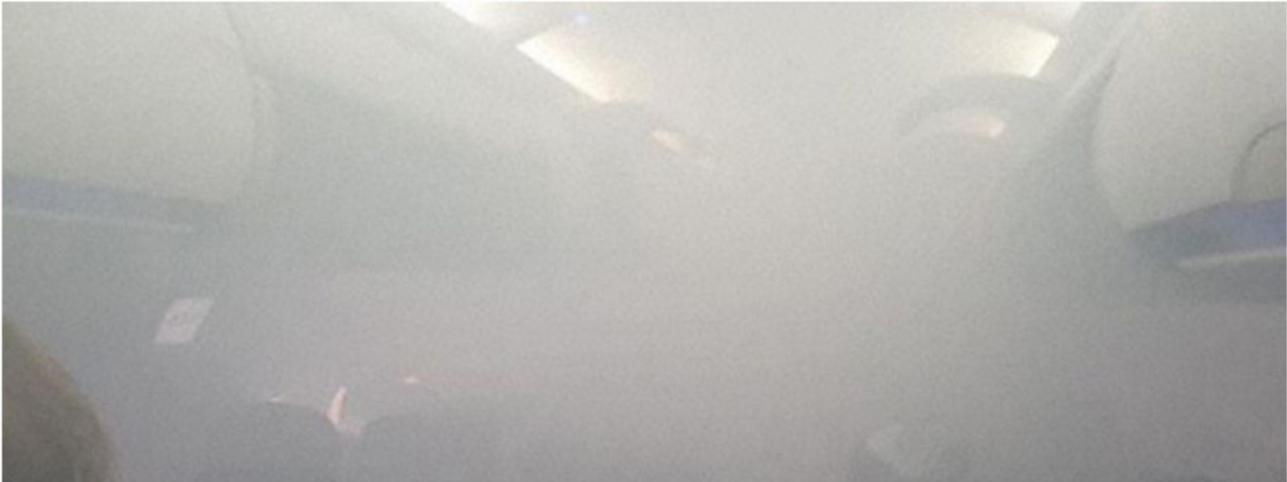
Figure 9 2019-08-05, British Airways BA-422, Airbus A321. On a flight from London Heathrow to Valencia, the aircraft was descending towards Valencia when smoke appeared in the cabin. It followed an emergency evacuation. The aircraft remained 9 days in Valencia and was subsequently ferried to London. After a total of 31 days the aircraft returned back to service (Ayan 2020). "It was found that no fire had occurred, but engine #2 (V2533, right hand) had lost all its oil. The engine was removed from the airframe and sent to the manufacturer for thorough inspection." This and more on: AvHerald 2019b. Picture source: Lucy Brown. Video: <https://youtu.be/tFsN0h09gAI>.

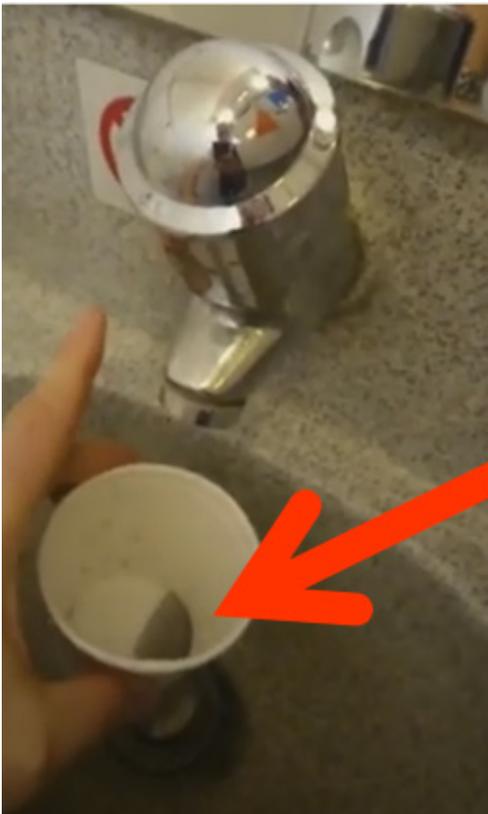
Figure 10

Compressed air from the engine is also used to pressurize the potable water tanks on some aircraft like the Airbus A320 (Scholz 2014b). It has been observed that the potable water on board can also be contaminated. Potable water contaminated by bleed air on an Airbus A320, is shown in **Figure 10**. It is the last water extracted from the tank before it is empty. This water is black, probably from engine oil residue.

Potable water contaminated by bleed air on an Airbus A320. This is the last water extracted from the tank before it is empty. This water is black, probably from engine oil residue. Picture source is a Video: <https://youtu.be/dlPOeudTTCI>. The video is explained: On the A320 the potable water tank is pressurized with bleed air. On the A320 also the hydraulic reservoirs are pressurized with bleed air. The bleed air presses on the free surface of the hydraulic fluid and gets as such in contact with it. The "mixture of hydraulic fluid vapor and bleed air" is connected via bleed lines with the potable water tanks. But flow into the potable water tanks is unlikely:

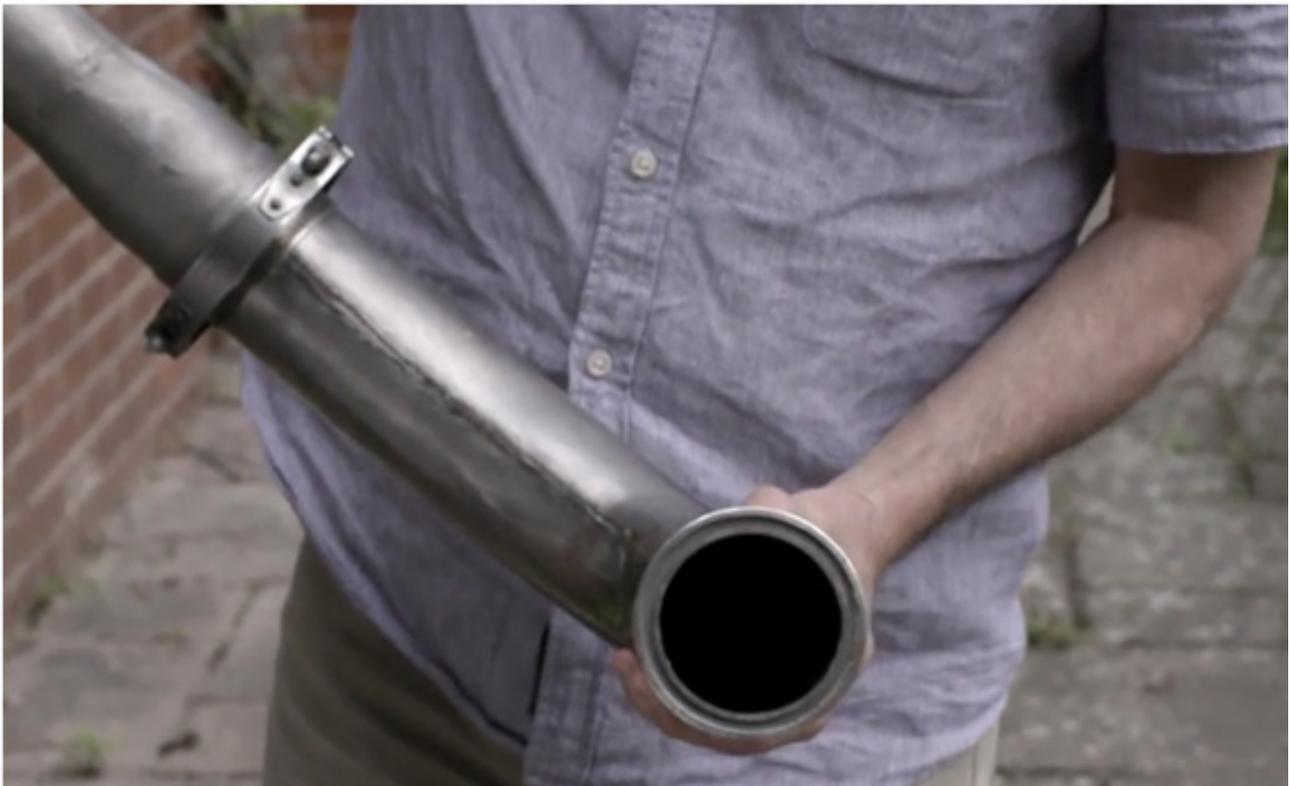
Ducting further downstream shows a black dry cover. The reason for the change in color seems to result from the different air temperatures: 400 °C at engine outlet and 200 °C further downstream behind the precooler. **Figure 13** shows bleed air duct of a Boeing 737 with black oil residue inside.

Figure 13 Engine oil colors bleed air duct black. Picture source: Video: <https://vimeo.com/groups/617439/videos/345959025>.

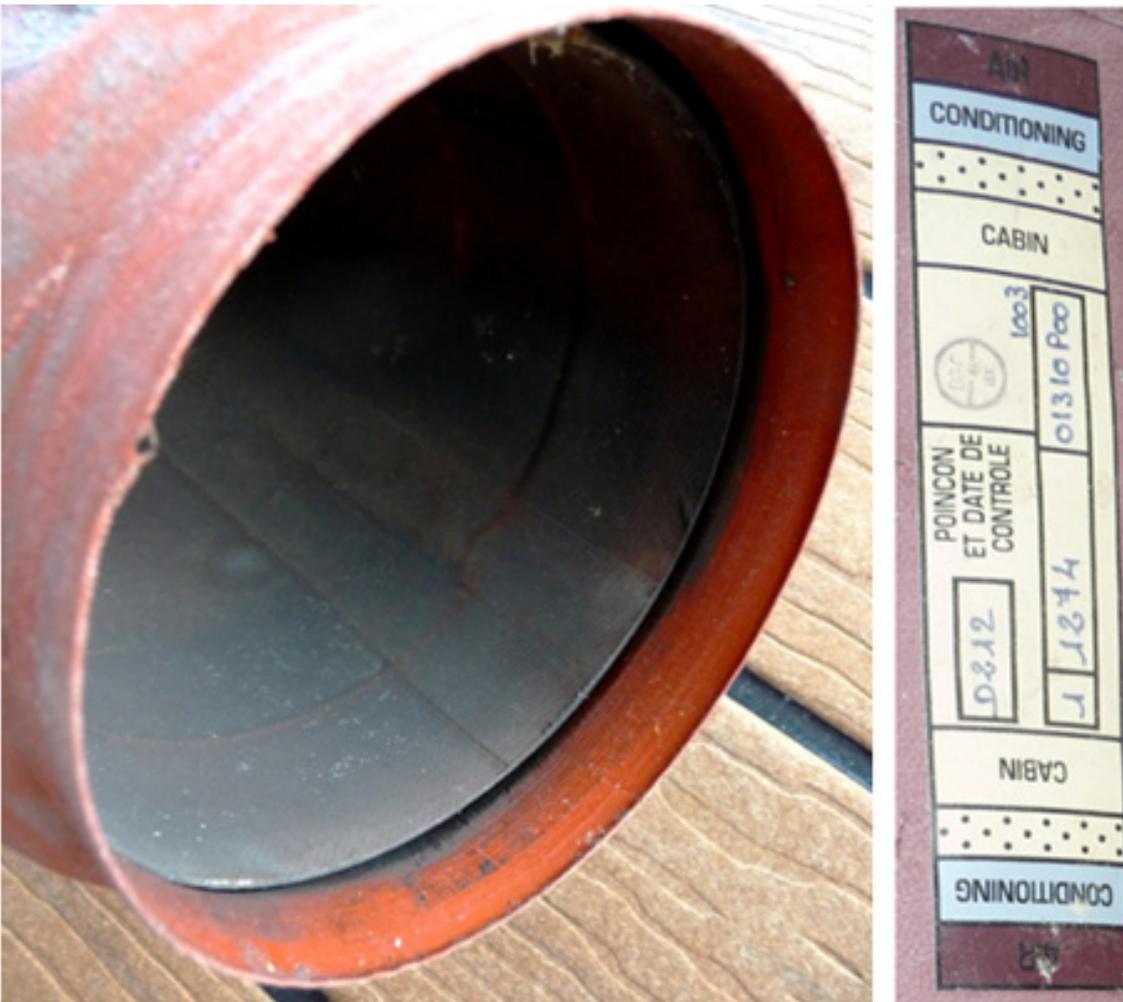
The air conditioning air distribution ducts in the cabin are black inside from contaminated bleed air. **Figure 15** shows the Airbus A320 air conditioning air distribution duct in the cabin. The inside is black from contaminated bleed air.

Figure 15 Airbus A320 air conditioning air distribution duct in the cabin.

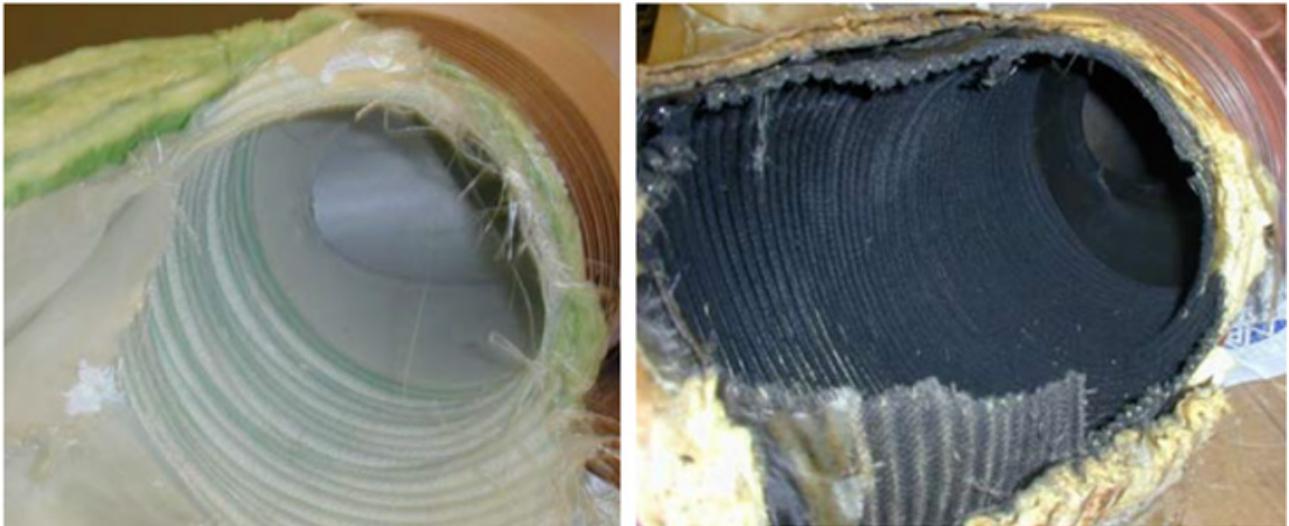
Figure 16 shows on the left side an unused duct supplied new. The right side of Figure 16 shows the same duct that had been installed downstream of the environmental control system air conditioning packs on a BAe 146 passenger aircraft after 26061 flight hours.

Figure 16 Left: Unused cabin air duct. Right: Used cabin air duct on a BAe 146 passenger aircraft (CAA 2004).

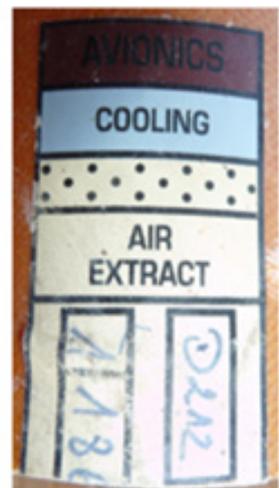
Air ducts are even clean inside at the end of the aircraft's life, in areas where they are used such that no bleed air flows through them. Such an example is shown in Figure 17. The inside of the air extract duct (located near the extract fan) is clean at the end of life of an Airbus A320, because the duct is normally not fed with bleed air. This disproves the argument that all ducts are black due to normal use over the course of decades in service.

Figure 17 Clean air duct at end of life of an Airbus A320.

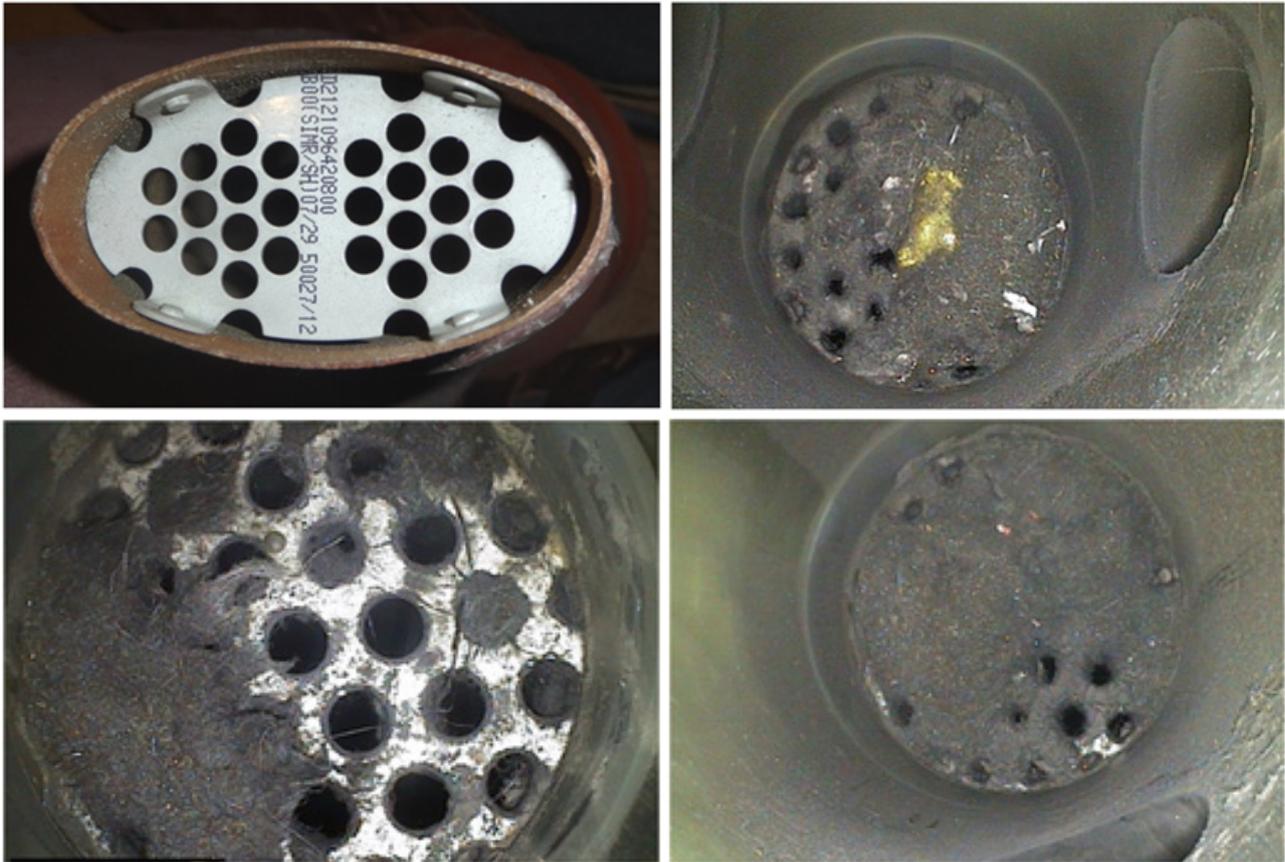
Flow limiter in air conditioning ducts have been found in ducts of the air conditioning system that are clogged from engine oil. **Figure 18** shows flow limiters clogged from pyrolyzed engine oil in ducts of the air conditioning system of Boeing 757 aircraft with Rolls-Royce RB211-535E4 engines operated by Icelandair (Hansen 2019) compared to a clean flow limiter (top, left).

Figure 18 Top left: Clean flow limiter in an air conditioning duct on an Airbus A320 (here in a dead-end duct section) compared to flow limiters clogged from pyrolyzed engine oil in ducts of the air conditioning system of Boeing 757 aircraft (Hansen 2019).

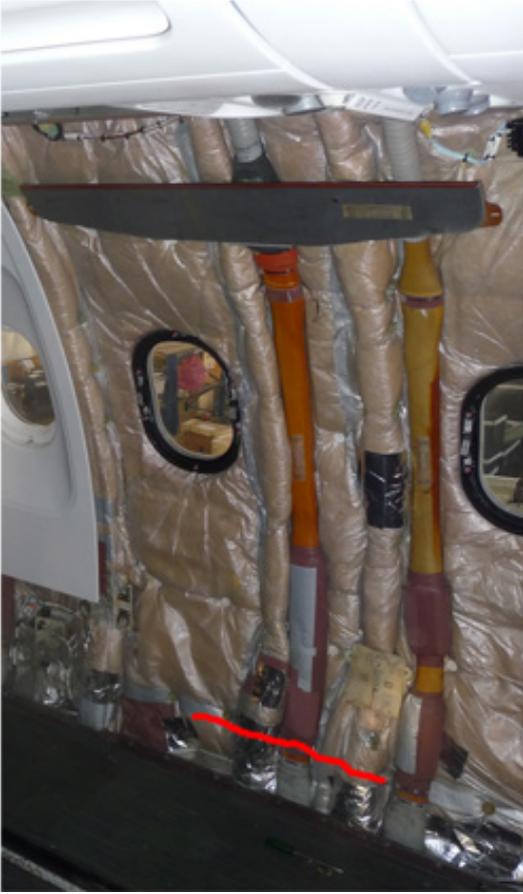
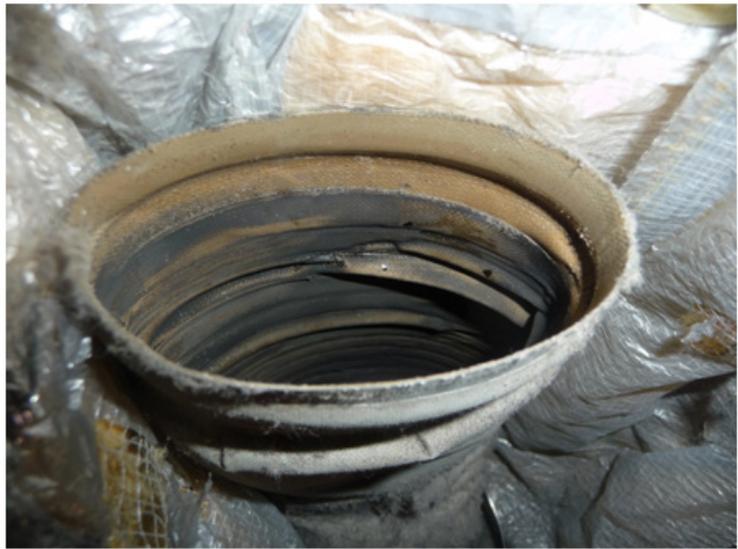
Figure 19 shows the riser ducts and lower cabin air outlet on an Airbus A320 aircraft. The red line in Figure 19 close to the cabin floor indicates where the duct was separated and opened. Looking down to the cabin floor shows a duct feeding the riser ducts. It is black inside from engine oil residue. **Figure 20** shows a view into the riser duct at that end, where it was separated at the cabin floor. It is also black inside.

Figure 19 Left: Riser ducts and lower cabin air outlet on an Airbus A320 aircraft. The red line close to the cabin floor shows, where the riser ducts are attached to their supply duct. See: Video: <https://bit.ly/2YXcl3a> (English subtitles available).

Top: View into the supply duct leading up into the riser duct on an Airbus A320. The inside is covered by a black residue.

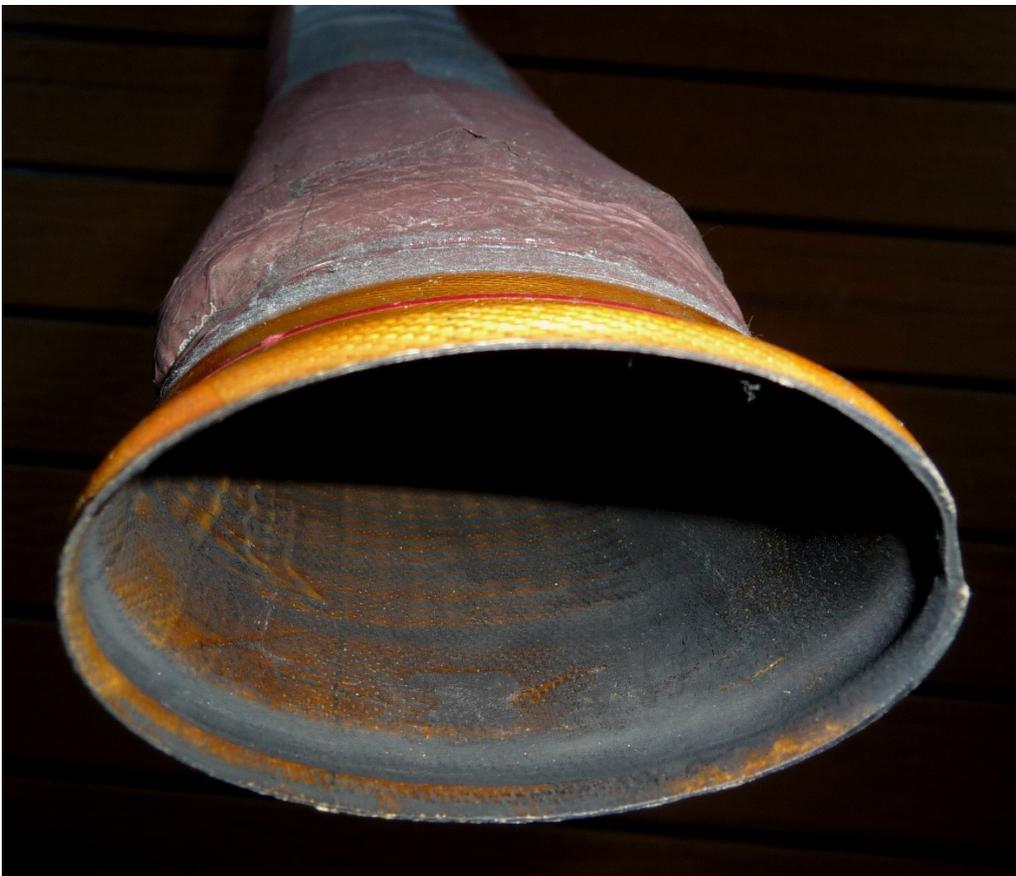
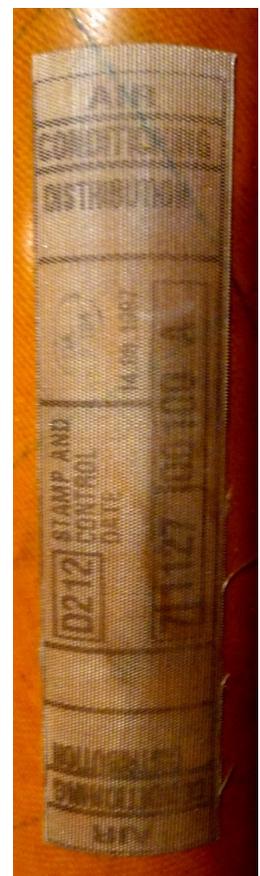
Figure 20 View into the riser duct where it was separated at the cabin floor. It is covered inside by black residue.

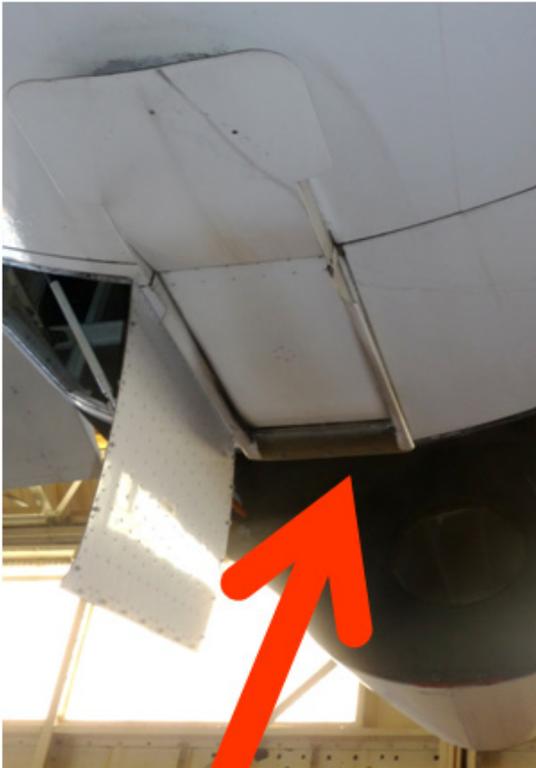
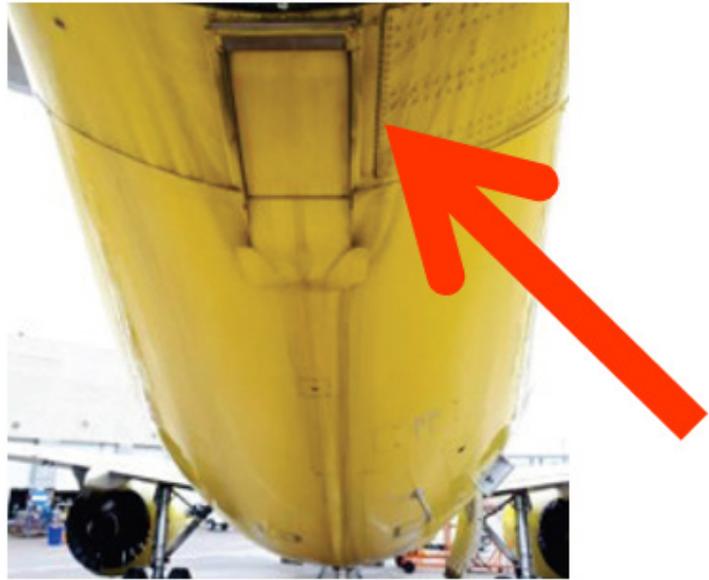
The left side of the **Figure 24** shows the air intake of the A320 APU. Fence and deflector around the APU air intake are clearly visible. These measures cannot fully prevent contaminants from entering the APU. On the right side of Figure 24 traces of contamination are clearly visible on the lower part of the fuselage. Carried by the air flow in flight, the contaminants reach the APU inlet.

Figure 24 Air intake of the A320 APU. Source of picture on the right: Airbus 2019.

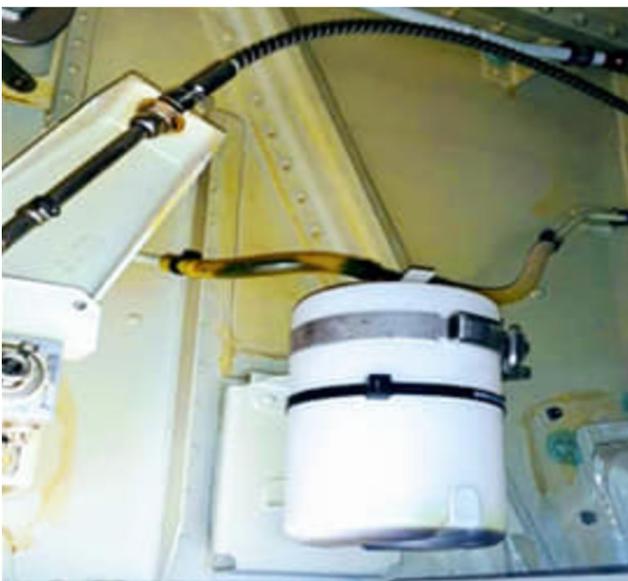
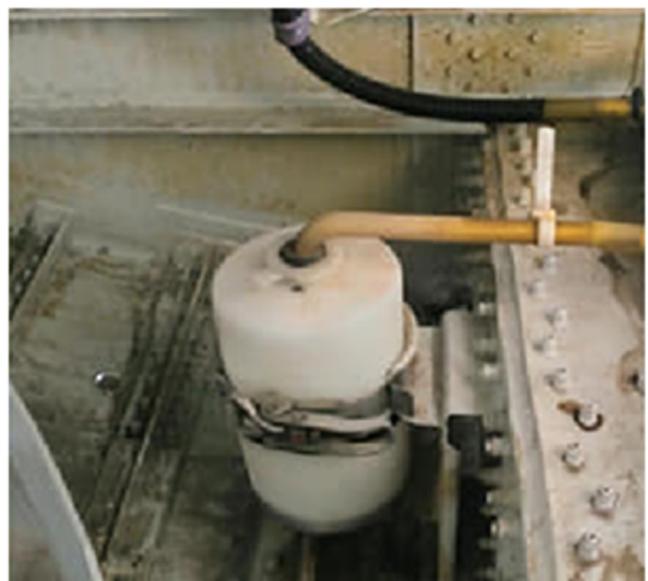
Hydraulic systems are never leak free. A hydraulic seal drain system tries to collect hydraulic fluid leaving the system with partial success. It is impossible to catch all leaking hydraulic fluid. If the containers of the seal drain system are not emptied, they spill over. **Figure 25 and 26** show the forward and aft collector tank of the A320 hydraulic seal drain system.

Figure 25 Forward (left) and aft (right) collector tank of the A320 seal drain system (Mekanikong 2019a and 2019b).

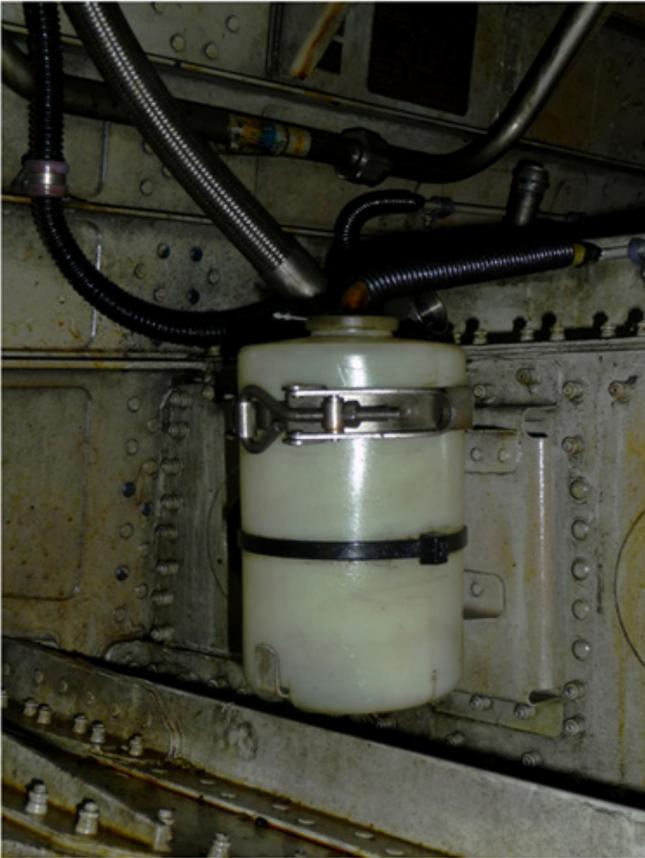
Figure 26

Aft collector tank of the A320 seal drain system, ATA 29-17 (Mekanikong 2019b). Forward and aft collector tanks collect hydraulic fluid from leaking equipment in the landing gear compartment, but spillover into the landing gear compartment when full. The photo tries to explain, what is meant with "the hydraulics industry must clean up its messy image". In this old Airbus A320, all surfaces in the landing gear bay are covered with a layer of hydraulic fluid. Dirt accumulates on the sticky surface. Logically, the hydraulic fluid is not confined to the inside of the hydraulic bay, but continues the lower side of the fuselage, if not cleaned constantly.

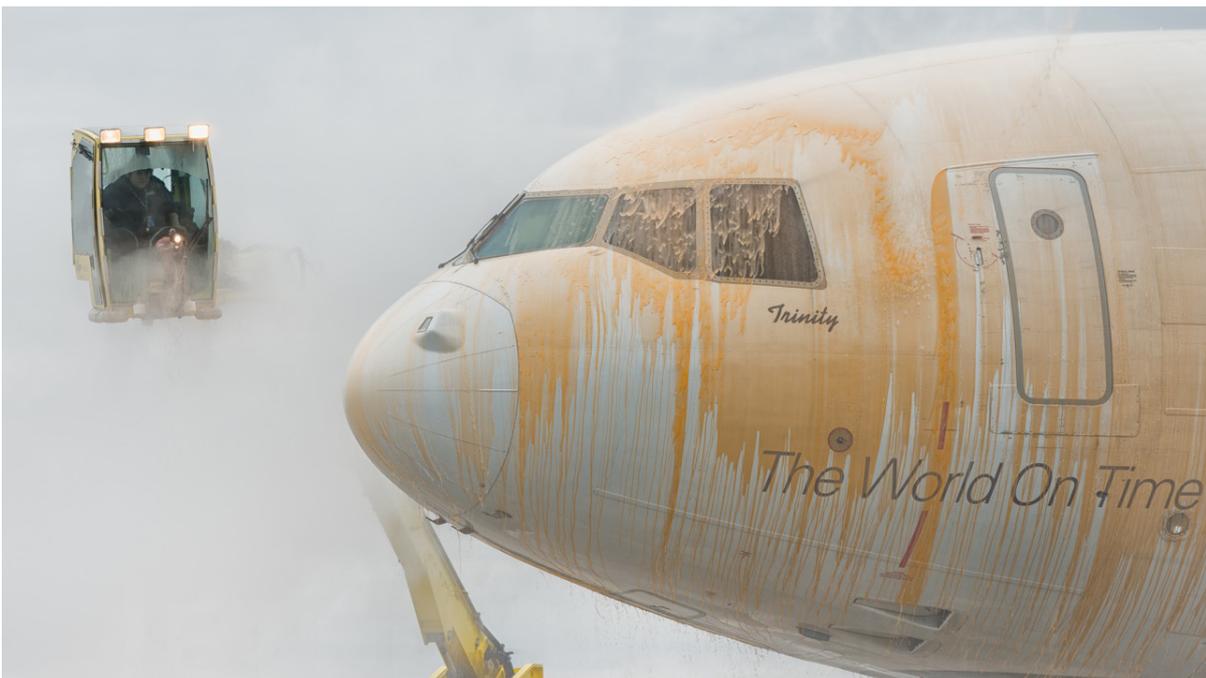
In **Figure 27** shows how deicing fluid is applied and how it covers the surface of an aircraft. The purpose is to clean the aircraft from frost and snow and to protect it from further onset. Deicing fluid can leak from the tail into the APU inlet as shown in **Figure 28**.

Figure 27 Leakage of deicing fluid (Petchenik 2015).

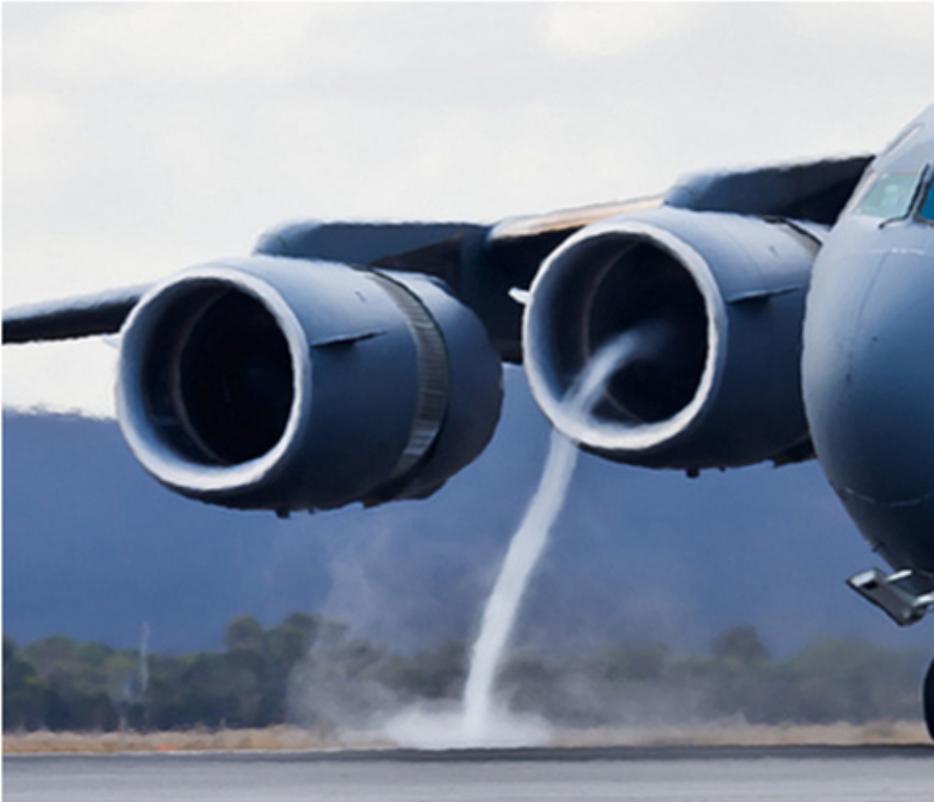
Figure 32 The ground vortex can also form between the ground and an engine on a high wing (Childs 2017).

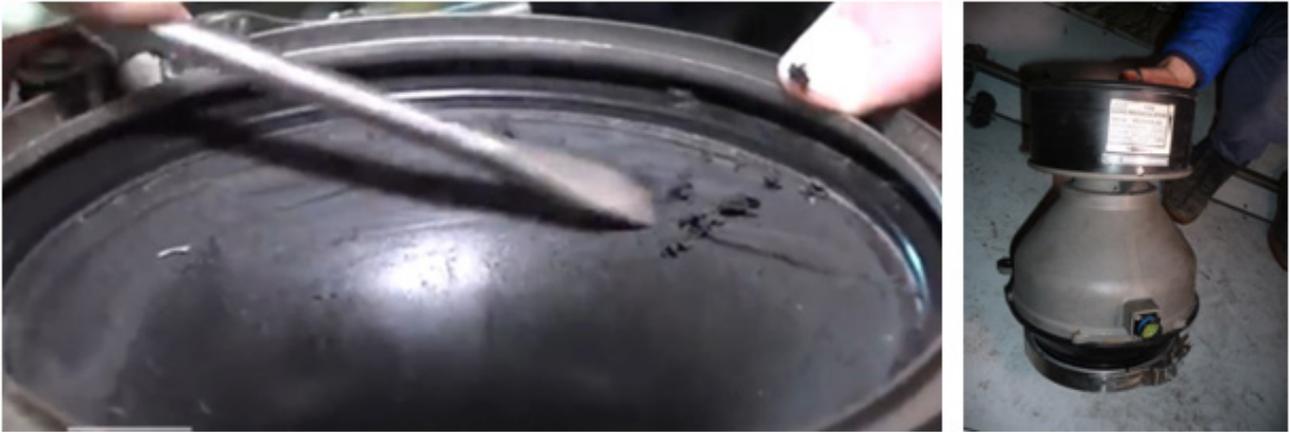
Figure 34 The recirculation fan of an Airbus A320 is covered by an oily black soft substance that can be scraped off with a screw driver. Picture source: Video: <https://bit.ly/2YXcl3a> (English subtitles available). A disassembled recirculation fan is shown on the right.

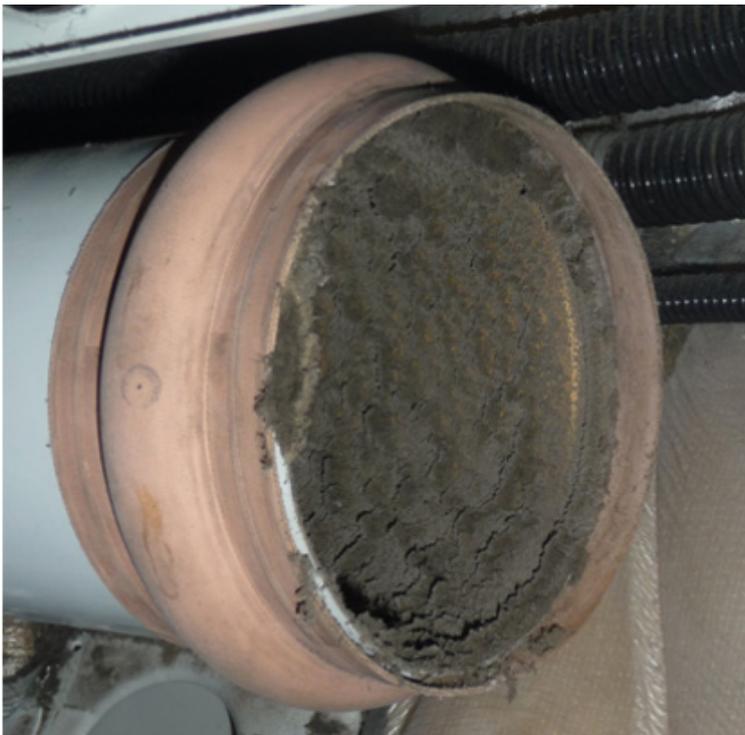
Figure 35 shows the ambient air inlet in the cargo compartment of the Airbus A320 for cargo compartment heating and ventilation. The inlet is full of moist dust.

Figure 35 The ambient air inlet in the cargo compartment of the Airbus A320 for cargo compartment heating and ventilation. The inlet is full of moist dust.
