ARIANE 5 RECOVERY BOOSTER FEM ANALYSES - VERIFICATION OF WATER IMPACT LOAD EVENTS

Dipl.-Ing. M. Groenewolt, Dr.-Ing. G. Schullerer,
MT-Aerospace, Franz-Josef-Strauß-Str. 5, Germany

Abstract

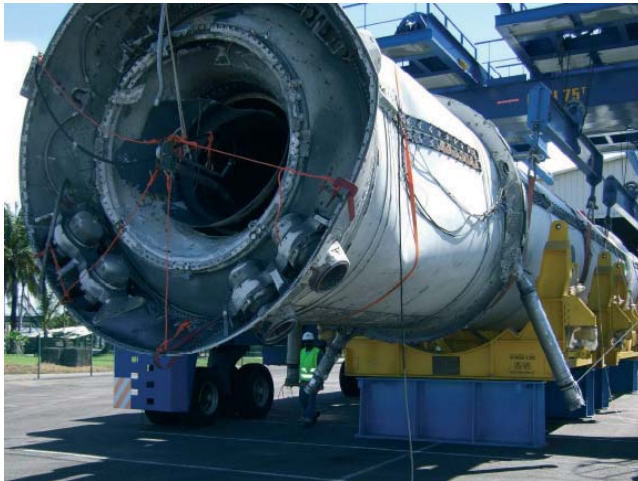
Figure 2 shows the buckled booster after water impact. An irreversible deformation of the last cylinder can be seen and the nozzle is also missing. MT-A as the manufacturer of the booster case was therefore asked to perform analyses concerning the buckle in cylinder V7. The objective was to assure the thesis that the water impact has caused the booster to buckle in the observed way.

Figure 2 Buckled Booster after recovering from Ocean (original photo by CNES)

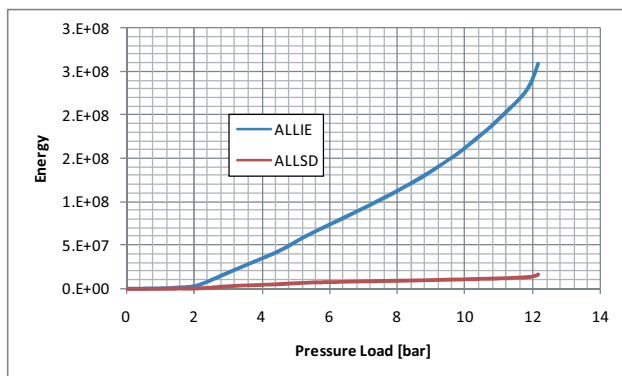
The static non linear analysis shows sudden convergence difficulties when reaching the onset of the local deformation. An adequate way to smooth severe discontinuities is to add viscous damping energy. To ensure that the effect on the results is small, the damping energy was compared with the total strain energy. Figure 5 shows that the total energy dissipated due to stabilization is small compared to the total energies involved in deformation. This ensures that the results are not influenced significantly by the viscous damping. In addition, calculations with different amounts of viscous damping have been performed. It was also possible to analyse the deformation without any stabilisation energy but then the time increments become very small. The difference in maximum deformation at the evaluation time between the calculation with small damping energy and the analyses without damping is smaller than 1.6%, but the analyses without stabilization needs almost twice as much cpu time. Therefore the analyses were performed with a small amount of stabilization energy, accounting also for the actual water impact, where water would produce a certain amount of damping as well as the inertia of the structure.

Figure 5 Stabilization energy (ALLSD) vs. total dissipated energy (ALLIE)

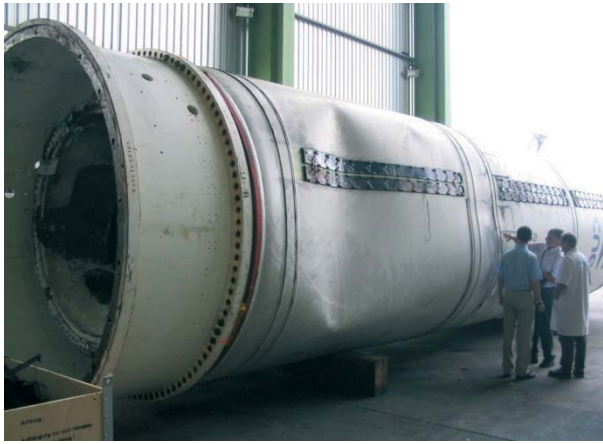
A number of reasonable load conditions have been analyzed and it was possible to identify a load combination which results in the observed deformations. The post predicted deformation field shows excellent agreement with the real deformation pattern. Magnitude as well as dimension and geometry of the buckle do match with the deformation in the lower segment, see Figure 8. Also the distribution of the buckle underneath the DAAR ring could be predicted accurately, refer to Figure 9.

Figure 8 Qualitative comparison of the prediction with the real deformation pattern (original photo by CNES).
