The Real Story of the Comet Disaster

De Havilland Comet – Structural Fatigue

Paul Withey

Lecture organised by RAeS Hamburg Branch

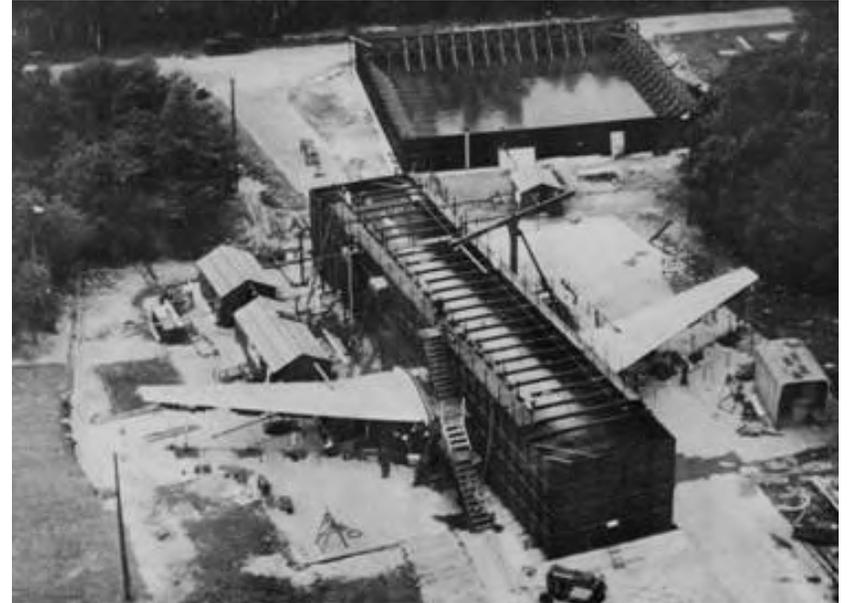
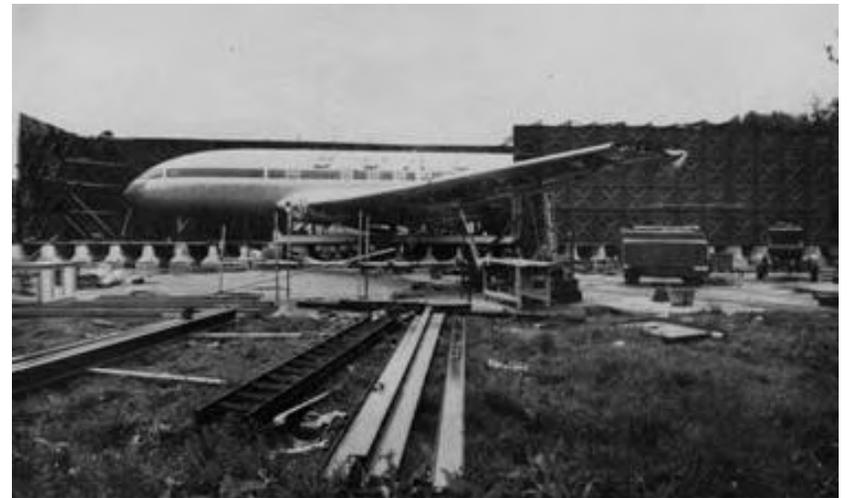
RAE Investigation – Fatigue Tests

- ❑ Fatigue tests on the pressure cabin and wings
- ❑ Full cabin fatigue test
- ❑ Water used to prevent explosive decompression
- ❑ Two water tanks built, 218,000 gallon (991,000 litre) each
- ❑ Simulated flight cycle loads applied using hydraulic rams
- ❑ Aerodynamic loads and gust loads (data from BOAC flights)
- ❑ Two hour flight simulated in five minutes

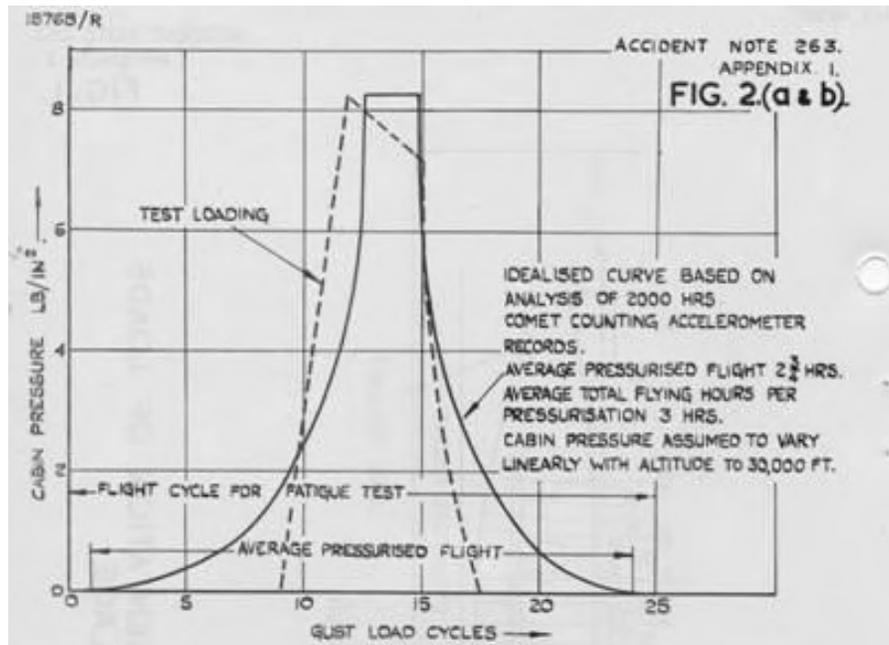
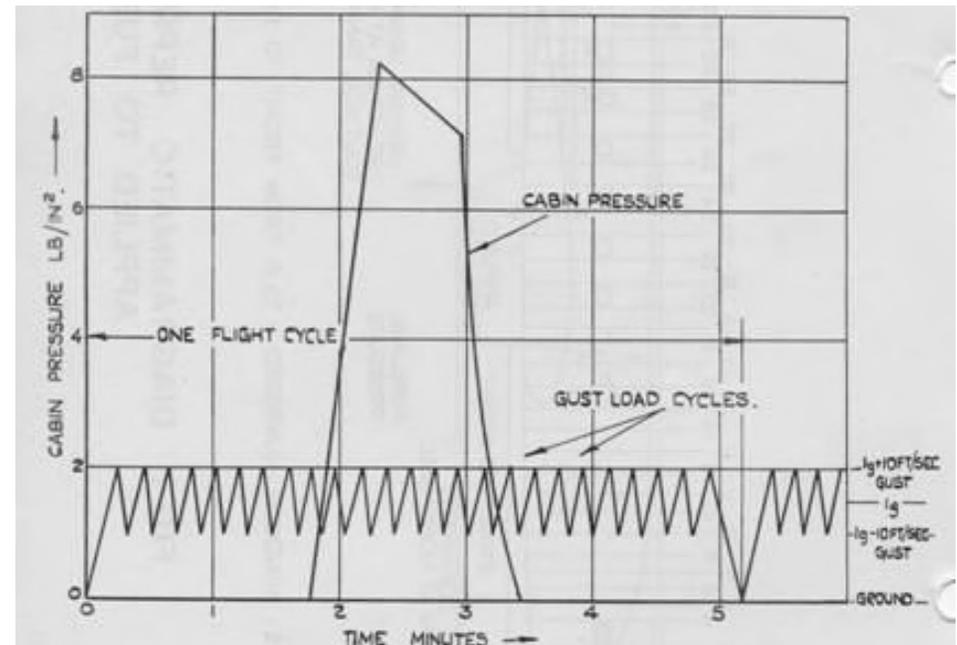
Gust and flight loads from BOAC flights

Simulated Cycle

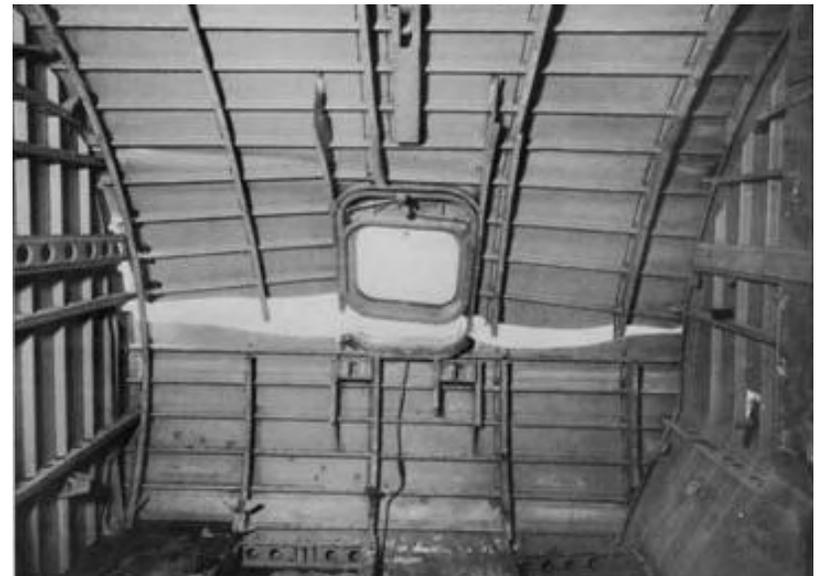
RAE Investigation – Fatigue Tests

- ❑ G-ALYU was placed inside the tank
- ❑ All internal cabin fixtures were removed and replaced with weights
- ❑ ‘YU’ had already completed 1121 Passenger flights
- ❑ ‘YU’ had completed 10 pressurised flights with de Havilland plus other tests
- ❑ A further 1826 simulated cycles were completed before fatigue failure of the pressure cabin from a crack growing from a rivet hole at the forward port escape hatch
- ❑ Total number of cycles completed was 3057

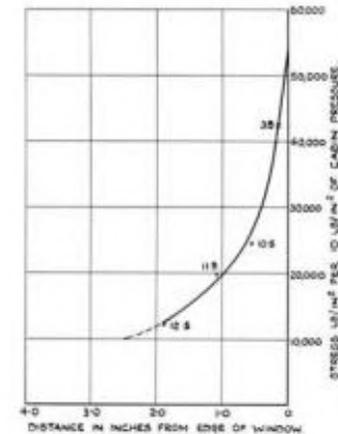
- Strain gauges used to establish the stresses around cut outs
- Peak stress at the edge of the window was estimated as:
 - 43,100 psi (297MPa) due to cabin pressure
 - 650 psi (4.5 MPa) due to flight loads
 - 1,950 psi (13.5 MPa) due to gusts
 - 45,700 psi (315 MPa) in total
- Peak stress was found to be 70% of the UTS (450 MPa)

FIG 8 SHOWING BUILD UP OF STRESS TOWARDS THE TOP AFT CORNER OF NO 2 WINDOW AT 10 LB/IN² CABIN PRESSURE

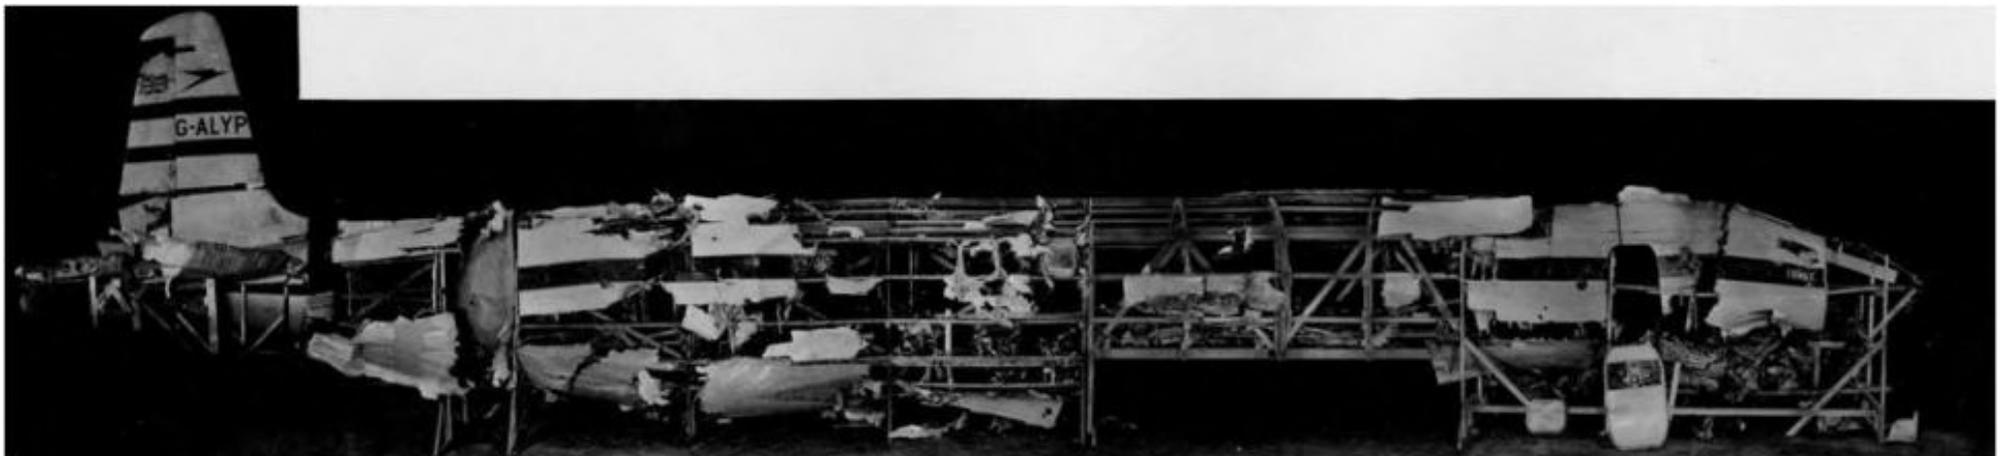
RAE Investigation – Re Build of ‘YP’

- The recovered wreckage was assembled on frames
- Allowed parts to be inspected in relation to adjacent parts
- Failure traced back to the upper forward portion of the cabin
 - Actual part recovered in August 1954

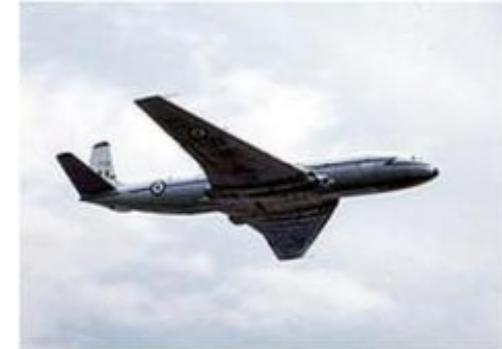
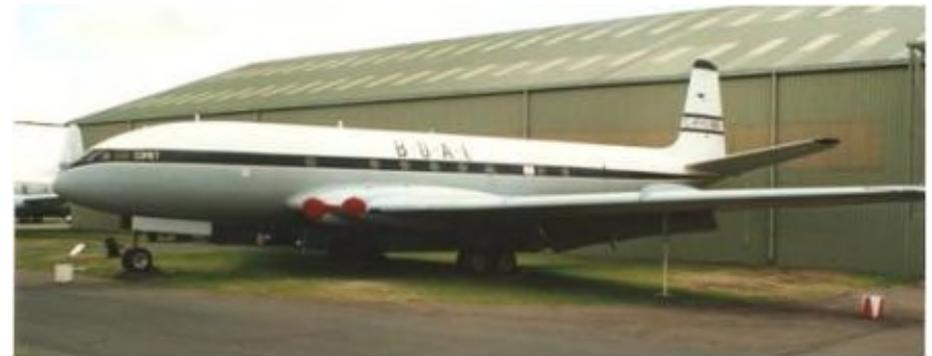
De Havilland Comet I

- ❑ The Comet I was grounded until changes were made to the pressure cabin
 - Thicker skin around the windows
 - Altered shape to allow 'Redux' fixing
- ❑ Increased weight due to modifications
 - Not economic as a passenger transport
- ❑ Used by the RAE for investigations or the RAF as transport
- ❑ Comet 2 and Comet 3 development was stopped
 - RAF used the Comet 2 as transport after modifications

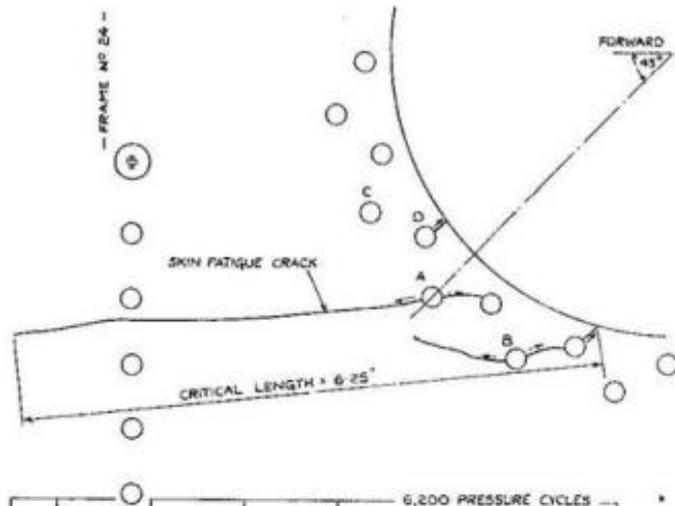
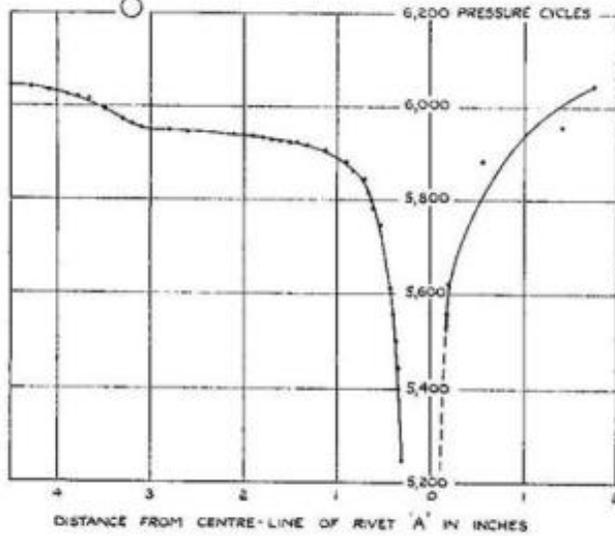
FIG. 21. Crack growth at third window, port side:
(Bottom forward corner)

FIG. 21. Crack growth at third window, port side:
(Bottom forward corner)

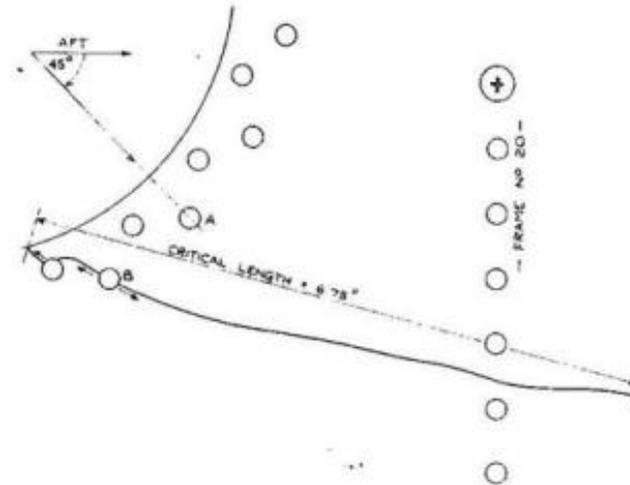
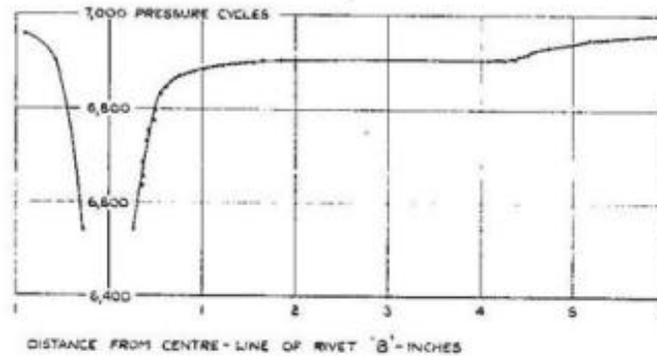
FIG. 22. Crack growth at first window, port side.
(Bottom rear corner)

FIG. 22. Crack growth at first window, port side.
(Bottom rear corner)

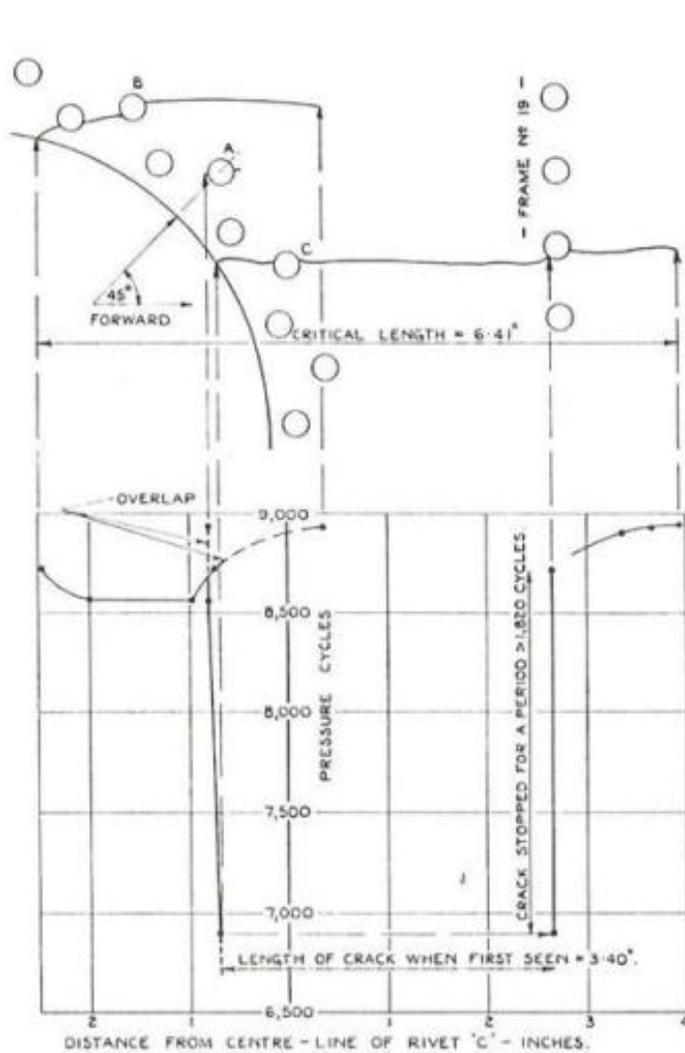
FIG. 25. Crack growth at first window, starboard side. (Top forward corner)

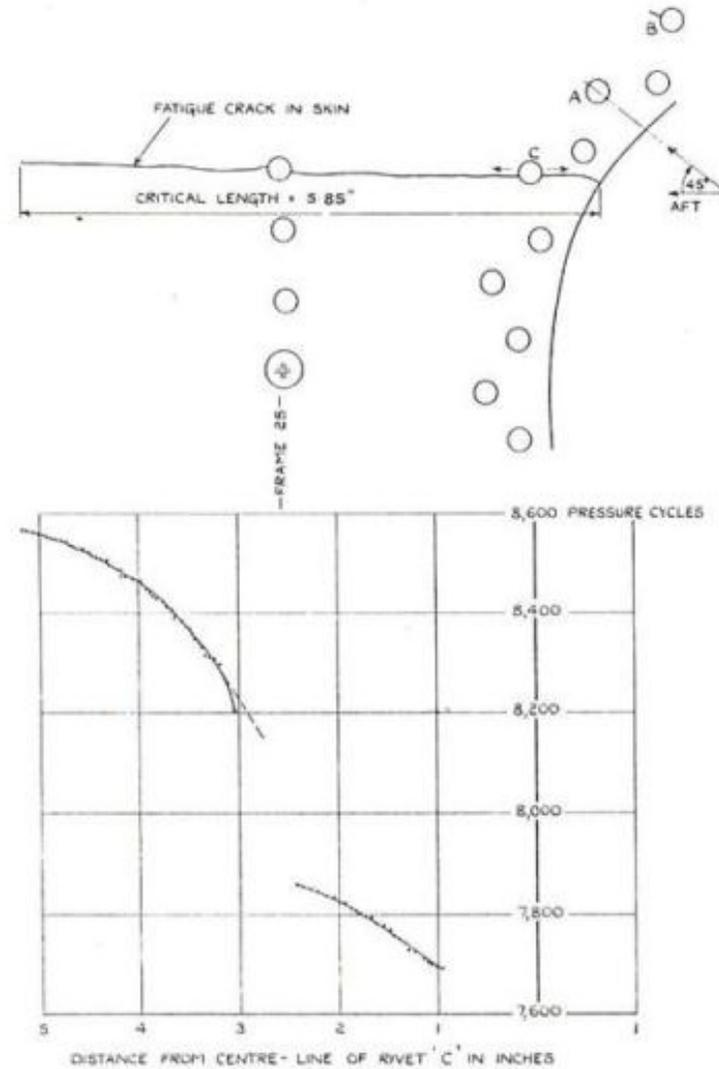
FIG. 26. Crack growth at third window, starboard side. (Top rear corner)

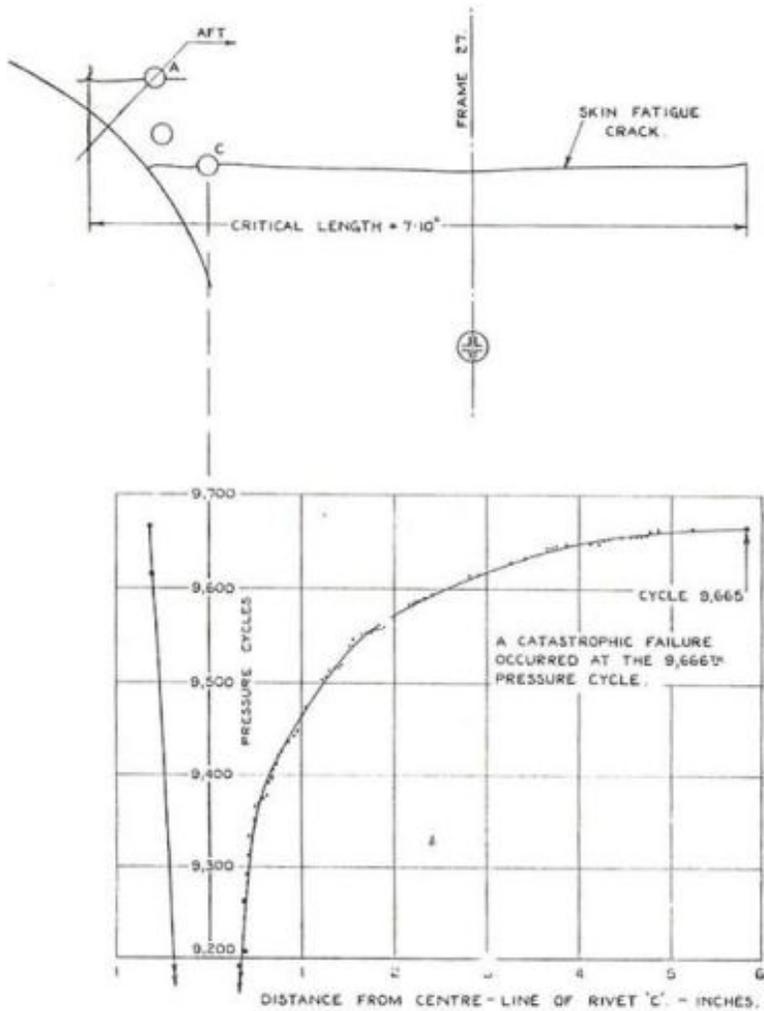
FIG. 29. Crack growth at fourth window, port side. (Top rear corner)

FIG. 29. Crack growth at fourth window, port side. (Top rear corner)

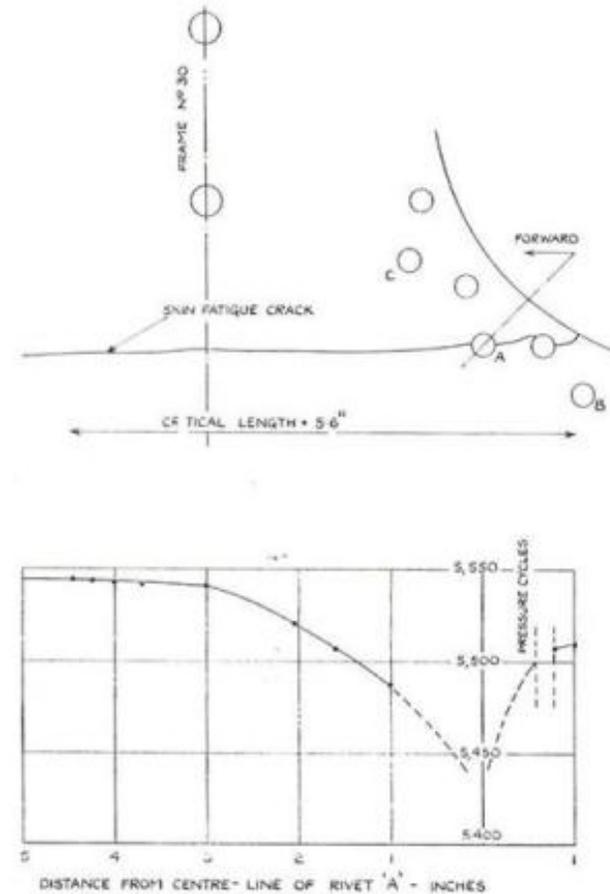
FIG. 30. Crack growth at No. 6 window, port side, in Comet G-ALYU. [N.B. The pressure cycles above include the 1231 pressurized flights made by this aircraft during service.]

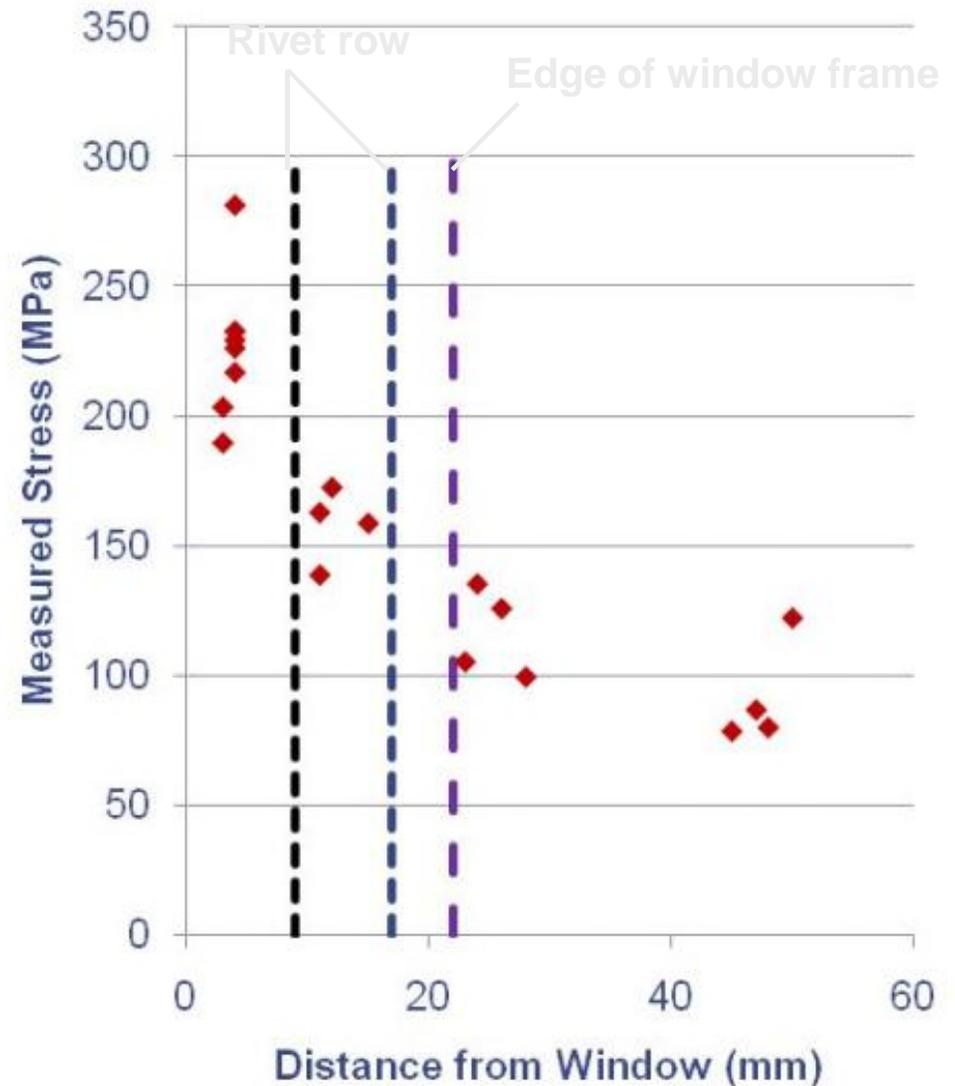
- Strain gauge measurements looked at the stress around the cut outs
- Stresses agreed with previous work
- High level of stress near to cut outs
- Stress dropped quickly away from the cut outs

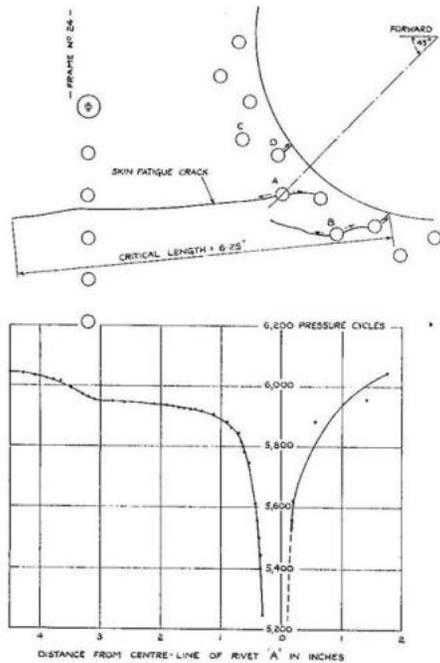
- Cracks grown to failure on Comet 'YR' in the water tank at the RAE
 - Data published showing loading cycles against crack growth

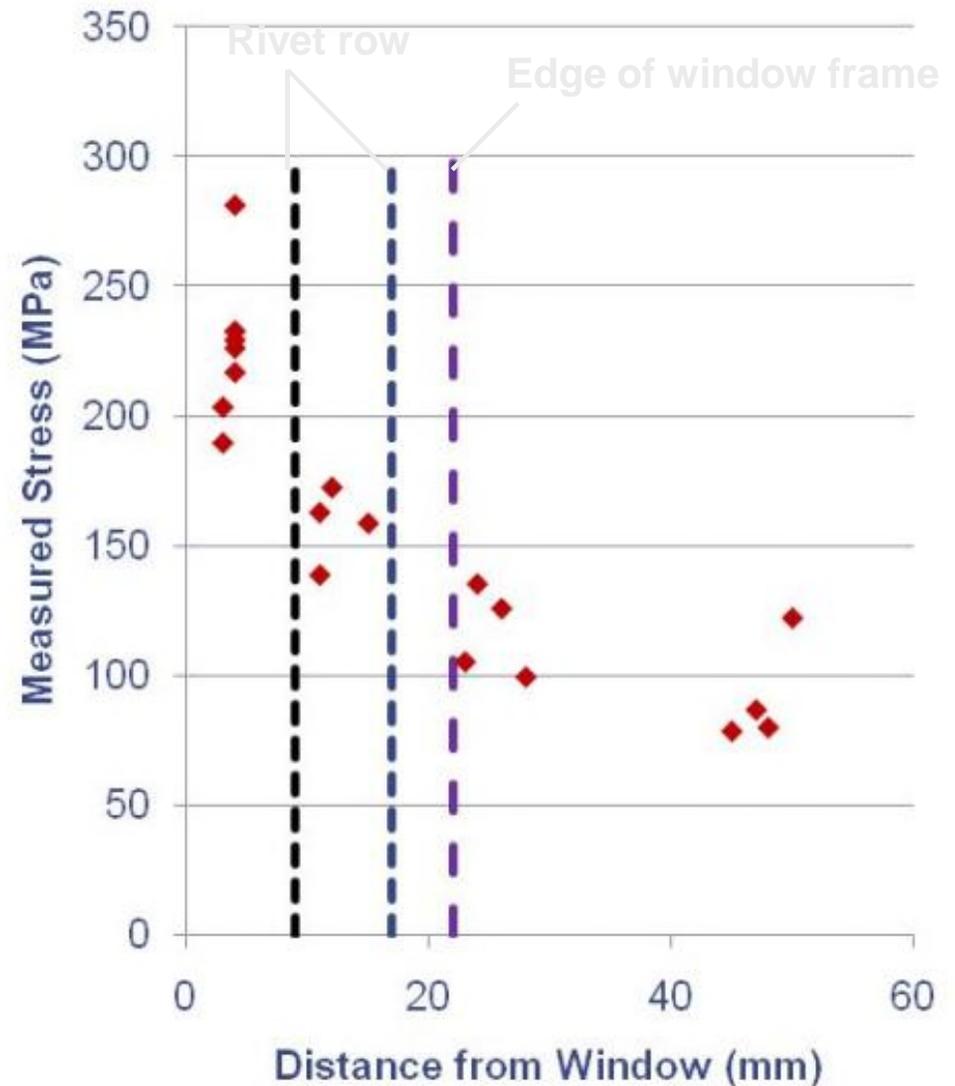
- Strain gauge measurements on 'YR' were also published
- Allows the stress range to be calculated for the various crack lengths

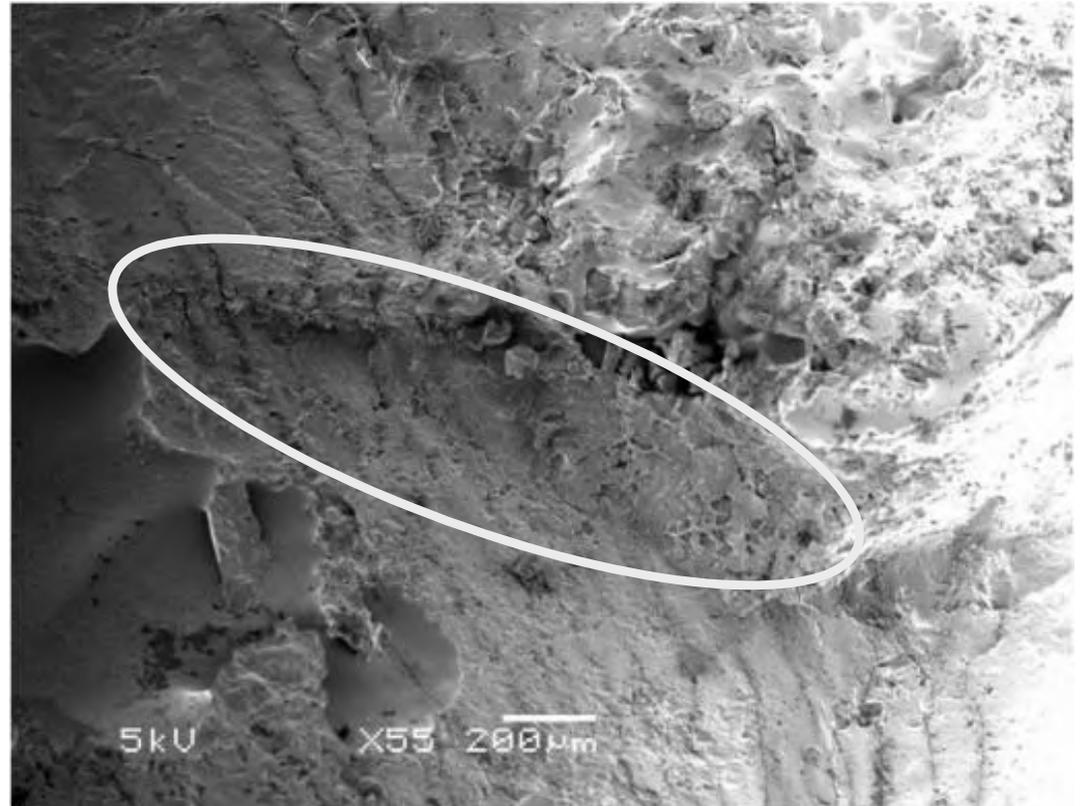
- Initial defect extends from bolt hole around 1.5 mm
- Then turns in the direction of maximum stress

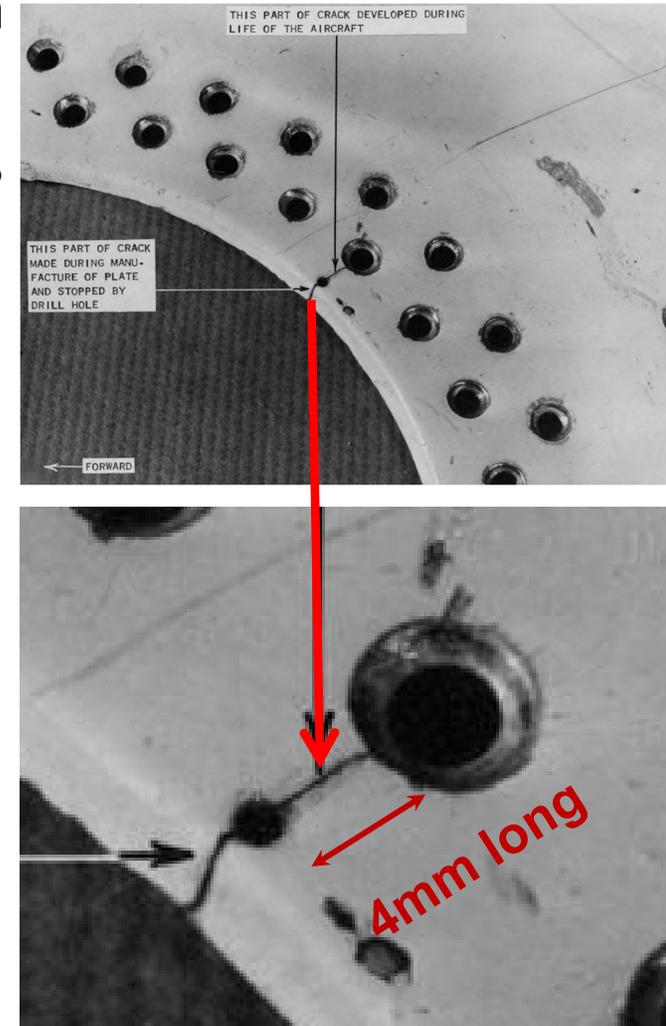
- Manufacturing cracks were present in the cabin skin
 - Rivets were pushed through causing cracks
 - Holes were drilled to ‘stop’ cracks
- Cracks could develop at the window rivets
 - Grew towards the window and stopped (seen on ‘YP’ and ‘YR’) (maximum crack length 20mm)
 - Grew away from the window into lower stress area and slowed down
 - Easy to spot and gave a cabin life of over 5000 cycles
- The critical crack length in a general area was around 165mm

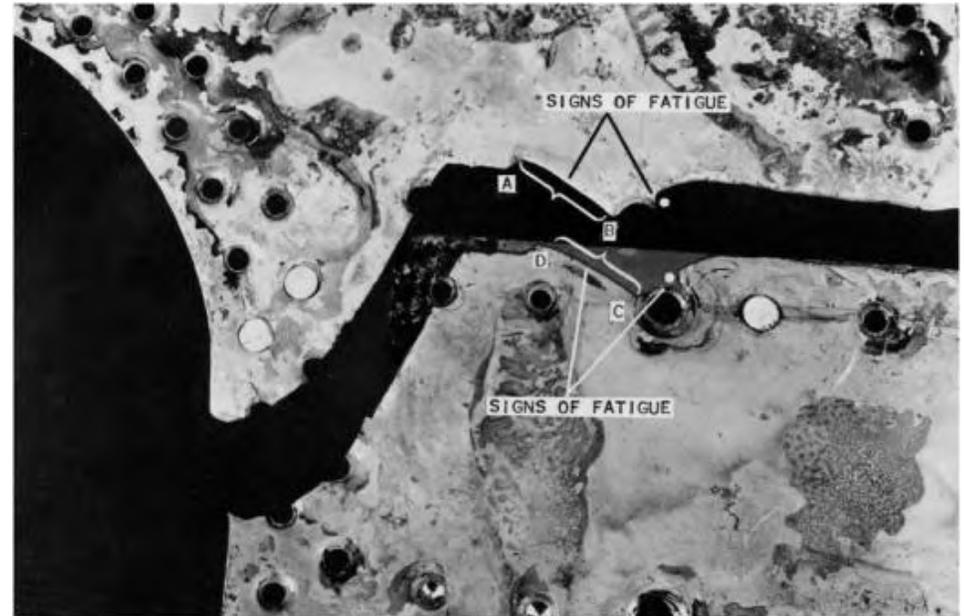
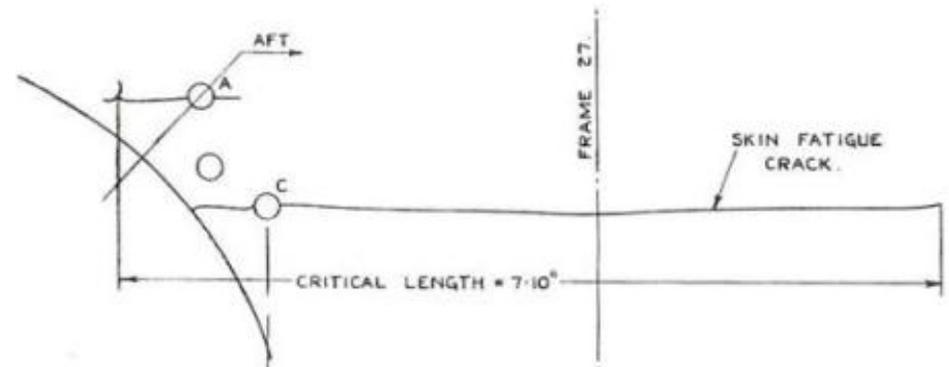
- ❑ Bolt hole on 'YP' was around 90mm from the window
- ❑ Cracks grew both forward and aft from the bolt hole
- ❑ The cracks grew in the skin under a doubler plate and could not be seen
- ❑ The forward crack was growing into an area of increasing stress and therefore accelerated rapidly
- ❑ When the crack reached the ADF window it exceeded the critical crack length

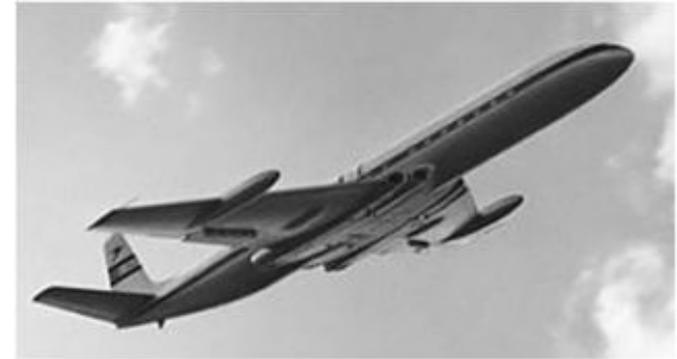
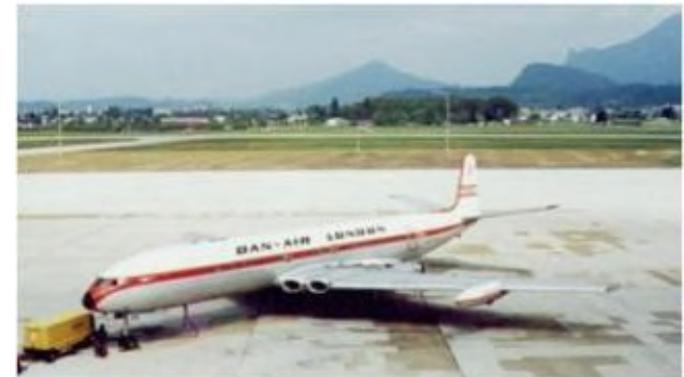
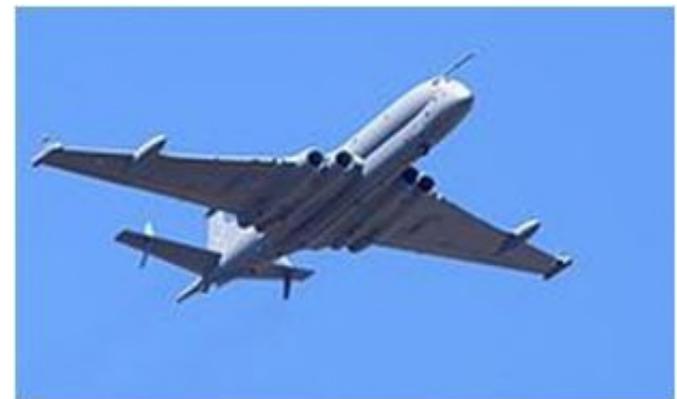
Comet 4

- The Comet flew again as the Comet IV
 - Different window design to reduce riveting
 - Fewer manufacturing cracks
- First airliner to fly a scheduled service across the Atlantic
 - 4th October 1958
- Remained in service as the Nimrod
 - 60 years after first Comet flight

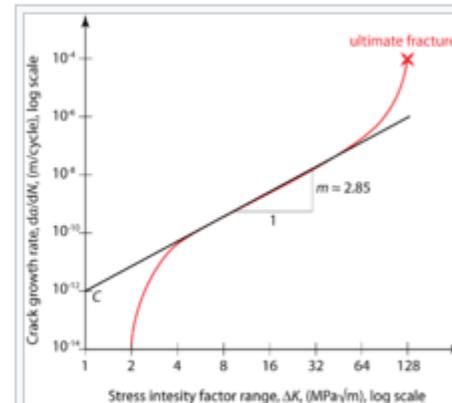
Schematic plot of the typical relationship between the crack growth rate and the range of the stress intensity factor. In practice, the Paris law is calibrated to model the linear interval around the center.

Paris examined a number of alloys and realised that plots of crack growth rate against range of stress intensity factor gave straight lines on log-log scales (see Figure). This implies that:
