# Aircraft Cabin Air and Engine Oil – An Engineering Update

Dieter Scholz

Hamburg University of Applied Sciences

International Aircraft Cabin Air Conference 2021

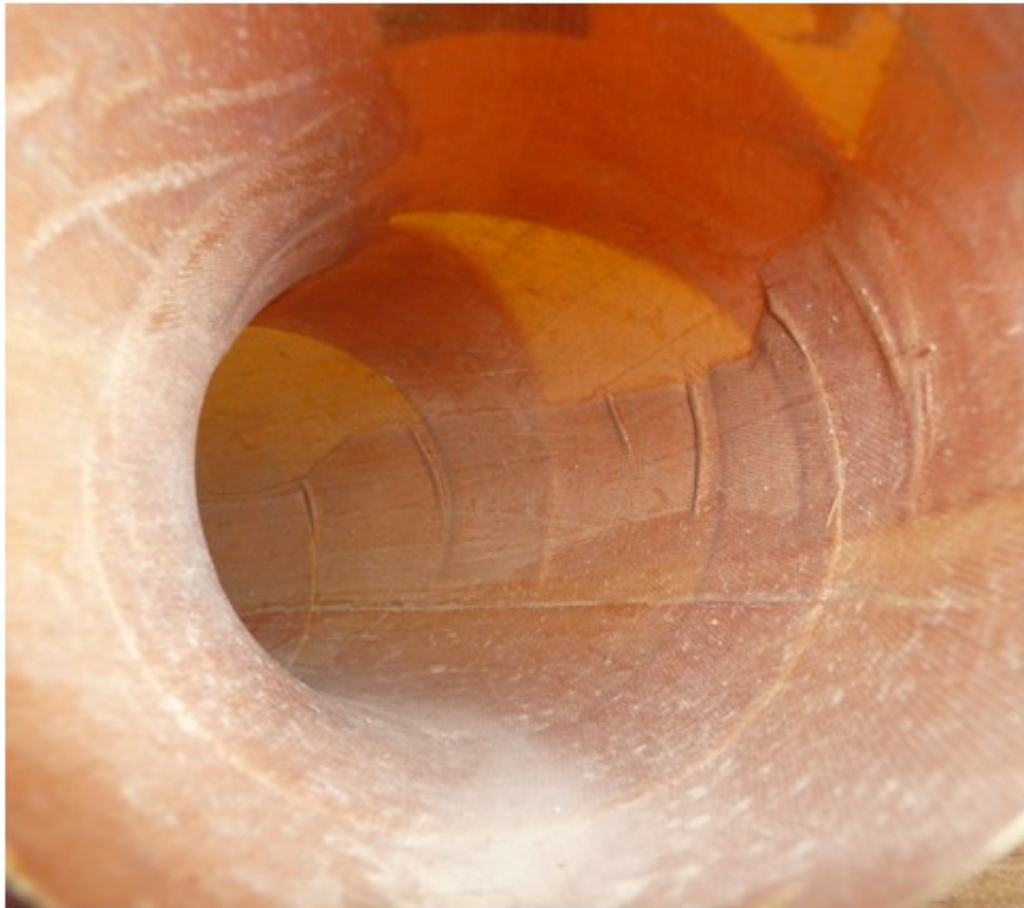
### Air Duct Is Clean at End of Life of an Aircraft, if Not Fed With Bleed Air

The inside of the air extract duct (located near the extract fan) is **clean** at the end of life of an Airbus A320, **because** the duct is normally **not fed with bleed air**.

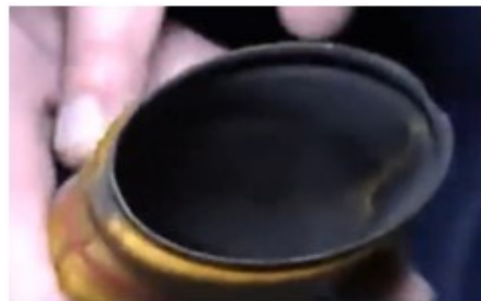
### Engine Oil Colors Riser Ducts Black

Riser ducts and lower cabin air outlet on an Airbus A320 aircraft. The red line close to the cabin floor shows, where the **duct was** separated and **opened**. It is **black inside** from **engine oil residue**.

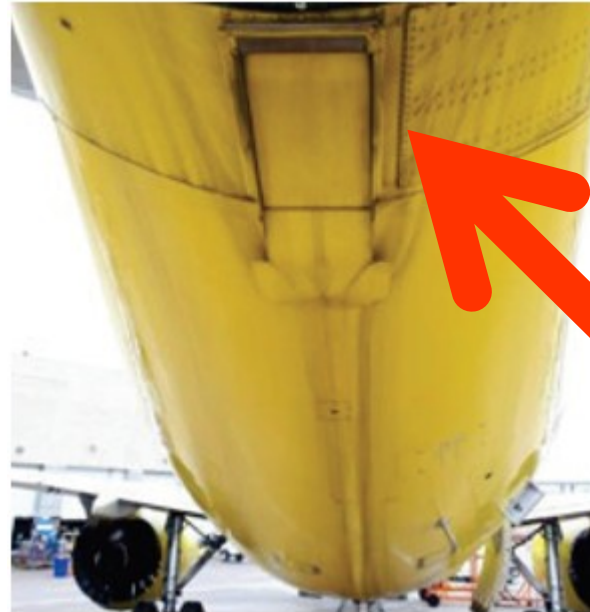
Left: Air intake of the A320 APU. Fence and deflector around the APU air intake are clearly visible. These measures cannot fully prevent contaminants from entering the APU. Right: **Traces of contamination are clearly visible on the lower part of the fuselage. Carried by the air flow in flight, the contaminants reach the APU inlet.** Source of picture on the right: Airbus 2019.

Aft collector tank of the A320 hydraulic seal drain system. In this old Airbus A320, **all surfaces** in the landing gear bay **are covered with a layer of hydraulic fluid**. Dirt accumulates on the sticky surface. **The hydraulic fluid is not confined to the inside of the hydraulic bay, but continues its journey on the lower side of the fuselage towards the APU inlet** (previous page).
