# Technical report

## IN-001/2024

Incident occurred on 17 February 2024 to aircraft Airbus A321, registration D-AISO, in Madrid (Spain)

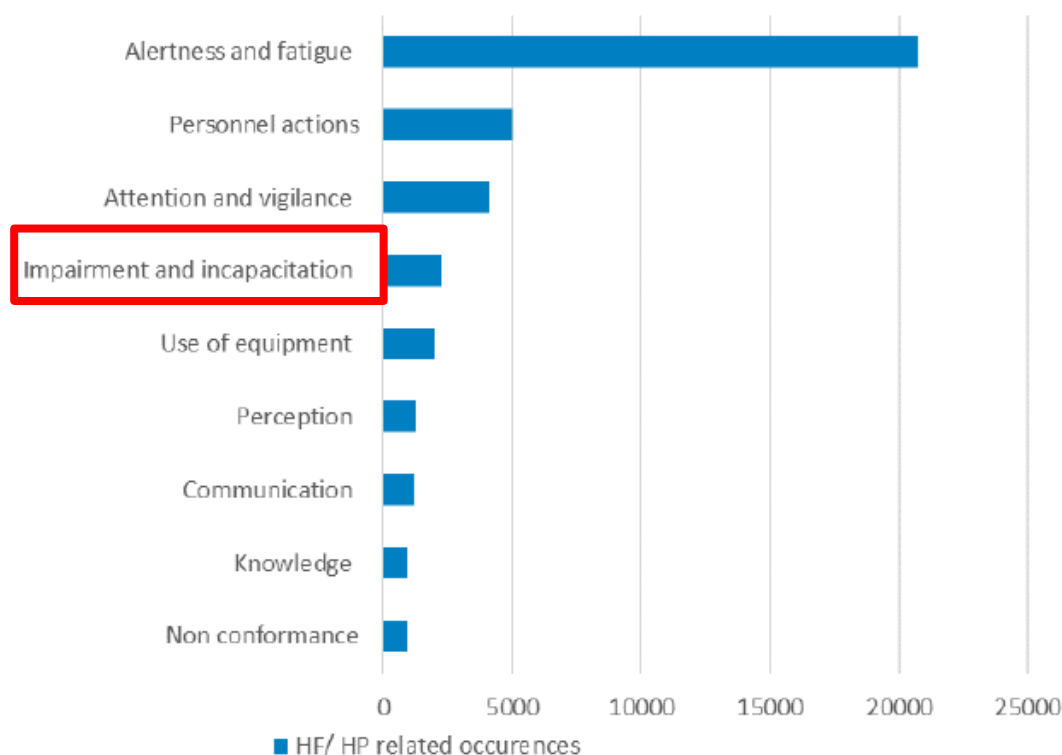
Figure 7: Number of events relating to human factors and human performance

The figure below shows the number of events relating to human factors (HF) and human performance (HP). It shows that “Impairment and incapacitation”, highlighted in red, is ranked no. 4.

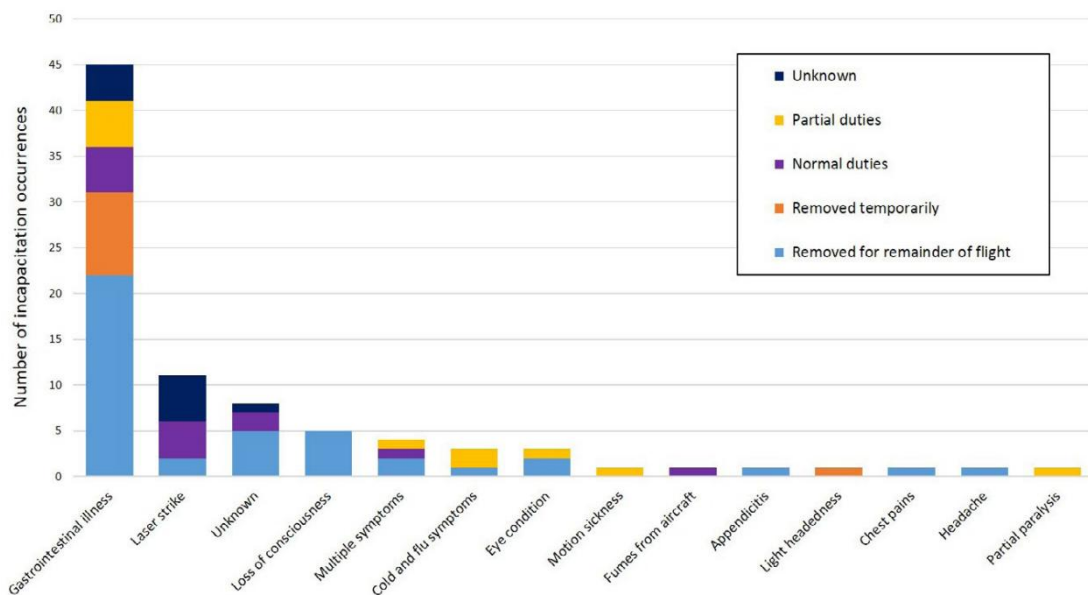
Figure 9: Causes of pilot incapacitation in high-capacity air transport operations (ATSB)

The **ATSB** published its study on “**Pilot incapacitation occurrences 2010-2014**”<sup>24</sup> in 2015, concluding that, in the period analysed, an average of 23 pilot incapacitation occurrences reported per year. Nearly 75% of incapacitation occurrences happened in high-capacity air transport operations (about 1 in every 34,000 flights), and the main cause was gastrointestinal illness, followed by laser strikes. In the majority of the occurrences reported, the incapacitation was severe enough for the pilot to be removed from duty for the remainder of the flight. With multi-pilot crews, these occurrences usually had a minimal effect on the flight.
