BIOINSPIRED SELF-HEALING COMPOSITE MATERIALS FOR SPACE AND AEROSPACE APPLICATIONS

R. Trask¹, I. Bond¹, G. Williams¹, H. Williams¹ and C. Semprimoschnig²

¹Department of Aerospace Engineering, University of Bristol, Queen's Building, University Walk, Bristol. BS8 1TR. U.K.

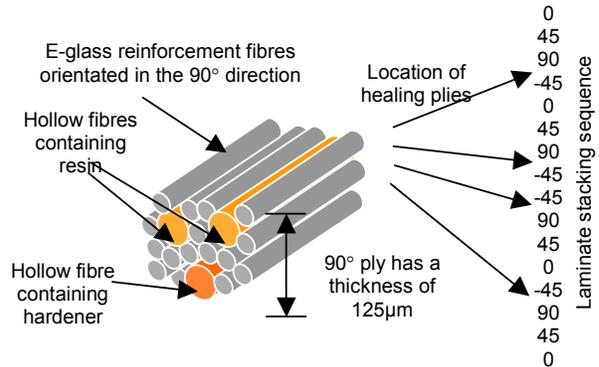
FIG.2 Location of Resin and hardener hollow fibres within the composite laminate

A 16 ply composite laminate with a $[0^\circ/+45^\circ/90^\circ/-45^\circ]_2s$ stacking sequence manufactured from pre-impregnated E-glass/913 epoxy resin (Hexcel Composites) was selected for the first evaluation of the HGF self-healing approach. Self-healing filaments were introduced at four $0^\circ/45^\circ$ damage critical ply interfaces that were identified and reported previously [21], as shown in Figure 3. An epoxy resin system (CYTEC Cycom 823) was selected as the healing resin because of the need to match the chemistry of the host laminate, it's availability as a two-part system permitting inclusion in separate storage filaments, it's low viscosity profile, and it's time to gelation of 30 minutes after mixing. Furthermore, it was observed experimentally that the individual components of the two-part Cycom 823 were sufficiently robust to survive the host laminate curing process (120°C for 1 hour) after infiltration into the hollow filaments within the fibre stack

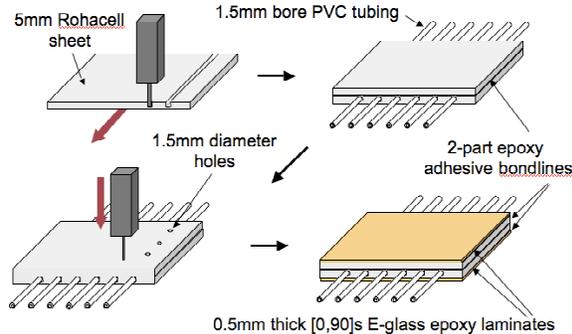
FIG. 3 Manufacture of vascular sandwich panels.

Sandwich cores were manufactured from 52kg/m³ Rohacell polymethacrylimide closed-cell foam. A schematic representation of the manufacture process for samples containing a vascular network is shown in figure 3, and is described in more detail in this section.

Initially, two half cores of 5mm thickness were used. Straight channels 2mm wide and 2.5mm deep were machined into one of the half cores. PVC tubing of 1.5mm internal and 2.5mm external diameter (Altec Ltd, UK) was laid into the channel after adhesive had been spread over the surfaces of both surfaces. The total resin coverage appropriate to produce a consistent midplane bond using this manufacture technique was found to be 1390g/m². Corebond 340 (SPSystems, UK) was selected on the

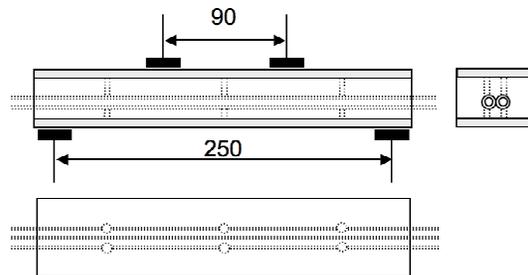
FIG. 4 Schematic representation of a two-part vascular network sandwich beam and four-point bend test setup. Not to scale.

basis of material properties, capacity for room temperature cure and high viscosity to avoid open channels becoming filled with resin during later processing stages. The centreline bond was oven cured in a vacuum bag at 60°C for 5 hours; the cure temperature was selected to limit deformation of the PVC tubing. This produced a core of 10.5mm thickness that appeared as a conventional core, but incorporated vessels close to the midplane. To form the network of risers, 1.5mm holes were drilled through the core and tube at appropriate locations. Additional Corebond 340 adhesive was applied to plug the exposed holes and allowed to gel for 24 hours at 20°C to seal the network for the subsequent stages. After this time the plugs were solid enough to be manually sanded flush with the surface of the core in preparation for bonding to the skins. Composite skins 300mm square of [0,90]_s layup and 0.5mm nominal thickness were prepared from pre-impregnated E-glass/913 epoxy (Hexcel, UK) using the recommended autoclave cure cycle. The top face of each plate was then sanded using P120 grit silicon carbide paper and lightly solvent cleaned using acetone. The skins were bonded to the core using Corebond 340 (SPSystems, UK) at 830g/m². This was also spread over both surfaces to ensure a consistent bond with minimum bonding pressure. To minimise the risk of the network becoming filled with resin, the skin bonding operation was completed at room temperature for 24 hours under deadweight pressure of approximately 2.8kN/m². A post-cure of 60°C for 5 hours was then applied to the whole panel to enhance the performance of all the bond lines. A schematic representation of a vascular sandwich panel designed for a two-part resin system, along with the four-point bend flexural test setup is shown in figure 4.

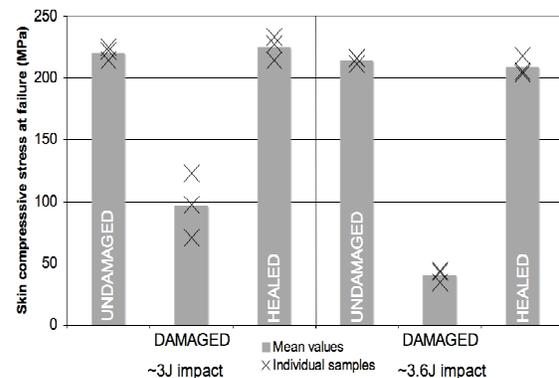
FIG. 5 Summary of mechanical performance of beam specimens. Healed specimens infiltrated with pre-mixed resin

The structural failure stresses are shown in figure 5 expressed as skin compressive stresses at failure for comparison purposes. In the undamaged and healed cases the failure mode is by a core shear yielding and then fracture; the ultimate load is taken as the point of failure. In the damaged specimens the buckling load has been taken as the point of failure; this has been taken as the point of first significant load fall or the knee in the curve in cases where there is no distinct fall. It is accepted that these loads could be considered somewhat arbitrary but they represent a good indication of the first point at which the structural performance of the specimens has been severely compromised.

In sandwich structures real impact damage is clearly subject to significant scatter, however the variation in performance of the damaged specimen at the lower energy level (Figure 5) doesn't detract from the success of the self-healing mechanism because the results suggest that this variability can be addressed successfully by the self-healing mechanism. Figure 12 shows a photograph of the region of damage viewed from the side, and clearly shows the cohesive crack and void in the foam core under the impact site has been filled by healing agent supplied from the vascular network. That this occurred in all samples shows that the rupture of the vertical riser is consistently achieved during impact deformation and confirms that the time required to infiltrate the damage is much less than the time for the resin to cure.

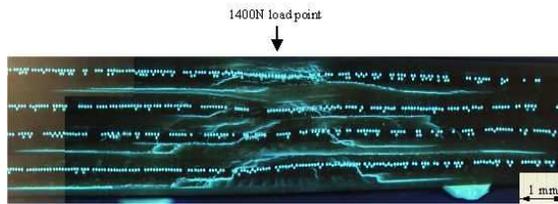
FIG. 6 Impact damaged cross-section of $[0^\circ/+45^\circ/90^\circ/-45^\circ]_2s$ GFRP laminate containing healing filaments at the $+45^\circ/90^\circ$ and $-45^\circ/90^\circ$ interfaces.

A damaged and healed GFRP specimen was examined to determine whether healing resin had infiltrated the damage zone. A cross-section of the healed damage illuminated under UV light is shown in Figure 6 which clearly illustrates the extent of the infiltration by the healing resin into the damage zone when viewed along the 0° fibre direction. This result suggests that the four self-healing layer locations were ideally placed within the complex damage network to fully infuse the damage site. To understand the mechanism involved in the self-healing of the damage zone further microscopic examinations were undertaken. This examination indicated the occurrence of crushed hollow fibres under the impact zone (Figures 7a and 7b) and healing resin bridging fracture surfaces (Figures 7c and 7d).

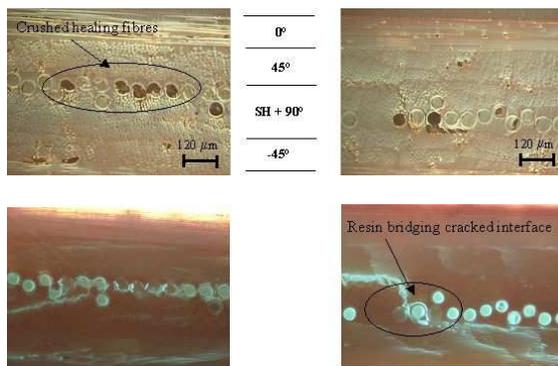
FIG. 7 Crushed-healing fibres located under the impact site viewed under normal (a) and UV (b) illumination. Healing resin bridging cracked interface viewed under normal (c) and UV (d) illumination

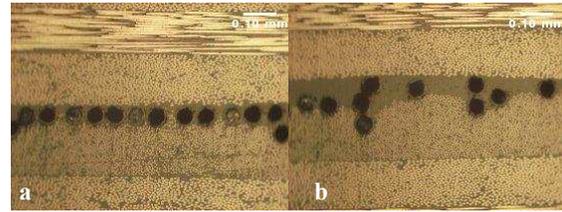
FIG. 8 HGF spaced at 70µm showing (a) good embedment and (b) fibre clumping within host laminate

A fibre spacing of 70µm (Figure 8) highlighted several issues about the resulting quality of embedding HGF within a laminate. This small pitch spacing was selected to ensure the HGF were in close proximity and thereby facilitate a high degree of healing efficiency. However, during preparation, HGF could be mislocated resulting in disruption to the host ply (Figure 8b). This was attributed to fluctuations in the fibre pitch control at low HGF spacing combined with poor tackiness of the 914 epoxy resin at ambient temperature. This was seen to result in lengths of HGF detaching from and reattaching to the surface producing fibre clumping and resin rich regions post-cure.

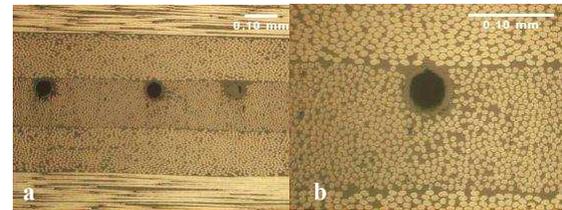
FIG. 9 HGF spaced at 200µm showing (a) consistent spacing and (b) excellent embedment within host laminate.

A fibre spacing of 200µm resulted in a much higher integrity laminate (Figure 9). The resin rich regions surrounding the HGF are minimised and there was no evidence of fibre clumping. The large spacing between fibres allowed the low tackiness of the 914 resin system to hold them in place, any that did detach were able to reattach without interfering with neighbouring fibres. The large spacing between HGF permitted excellent consolidation during cure further improving overall HGF embedment and reducing disruption to the laminate.

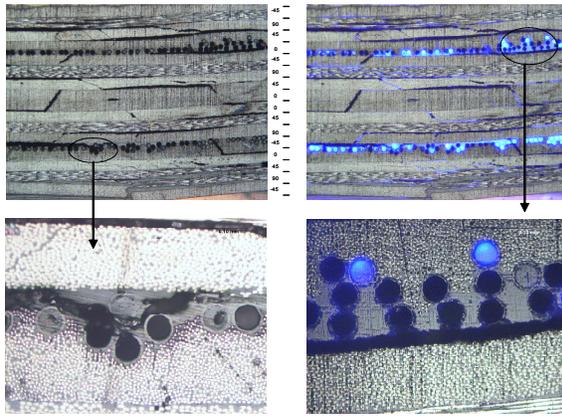
FIG. 10 (a) Damage distribution within laminate (top left), (b) damage infiltration with healing resin and fluorescent dye (top right), (c) delaminations deviating from interface (bottom left) and (d) propagating along interface causing HGF fracture (bottom right).

Microscopic analysis of samples after quasi-static indentation highlighted the mode of damage development and the interaction with the HGF. The cross sectional damage distribution was typical of an impact damage event. A localised 'crushing' zone was evident on the upper surface followed by shear cracks and delaminations of increasing length through the thickness of the laminate culminating in the largest delamination at the back face between the final two plies of the stack.

The region of HGF immediately under the impactor was subject to 'crushing' forces, the consequences of which were difficult to discern clearly using optical microscopy. However, the majority of HGF fracture within the laminate is evident from Figure 10a where shear cracks and delaminations are seen to intercept regions of HGF. Furthermore, Figure 10b shows similar damage infiltrated with healing resin mixed with fluorescent dye. It can be seen from this image that the larger delaminations ($>30\mu\text{m}$) contain little or no healing resin. This could be due to the inability of capillary action alone to draw significant volumes of resin into the relatively wide cracks, combined with the limited lengths of HGF available for delivery of resin (test specimen width provided $\sim 40\text{mm}$ HGF length adjacent to damage site).

In Figure 10c, clusters of HGF cause deviation of a delamination, presumably due to a fibre cluster and the resulting resin rich region causing a weakness in the laminate. However, the propagating crack passes directly through HGF causing fibre rupture and release of healing resin. In Figure 10d, HGF are ruptured as a delamination propagates along a ply interface. This suggests their fracture toughness is similar to the surrounding epoxy matrix - a desirable situation for encouraging HGF fracture.

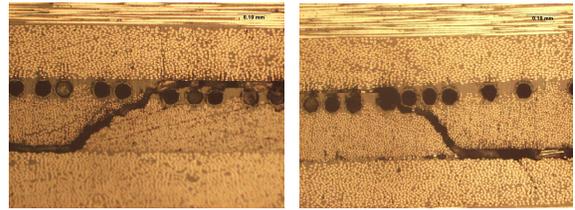
Fig 11 Intra-ply shear cracks intercepting HGF within a self-healing CFRP laminate

The presence of intra-ply shear cracks linking delaminations provide connectivity between different damage sites in the laminate and facilitate healing at multiple interfaces. Shear cracks can be seen to initiate HGF fracture by similar mechanisms to delaminations

(Figure 11). However, the width of shear cracks is generally smaller than delaminations ($\sim 10\mu\text{m}$ compared to $\sim 30\mu\text{m}$) and so encourage a stronger capillary action to transport healing resin.

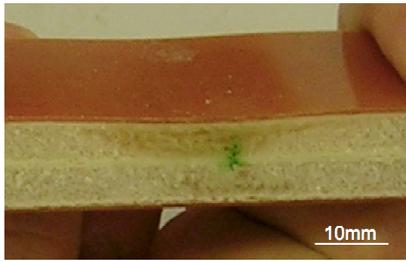
FIG 12 Photograph of a vascular sandwich beam subjected to impact of a 2.8kg cylindrical impactor dropped from 130mm. The damage void has been infiltrated with pre-mixed epoxy resin healing agent through the vascular network in the core.

This study shows that the physical mechanism of using an impact load to rupture channels in the foam which allow healing agent to bleed into the damage is a successful method of initiating self-healing in sandwich structures. Following initiation, the damage zone is successfully infiltrated under only moderate pressures and curing of the resin restores undamaged failure mode and strength.
